3. STATE HISTORICAL PROPERTIES RISK ASSESSMENT

INTRODUCTION

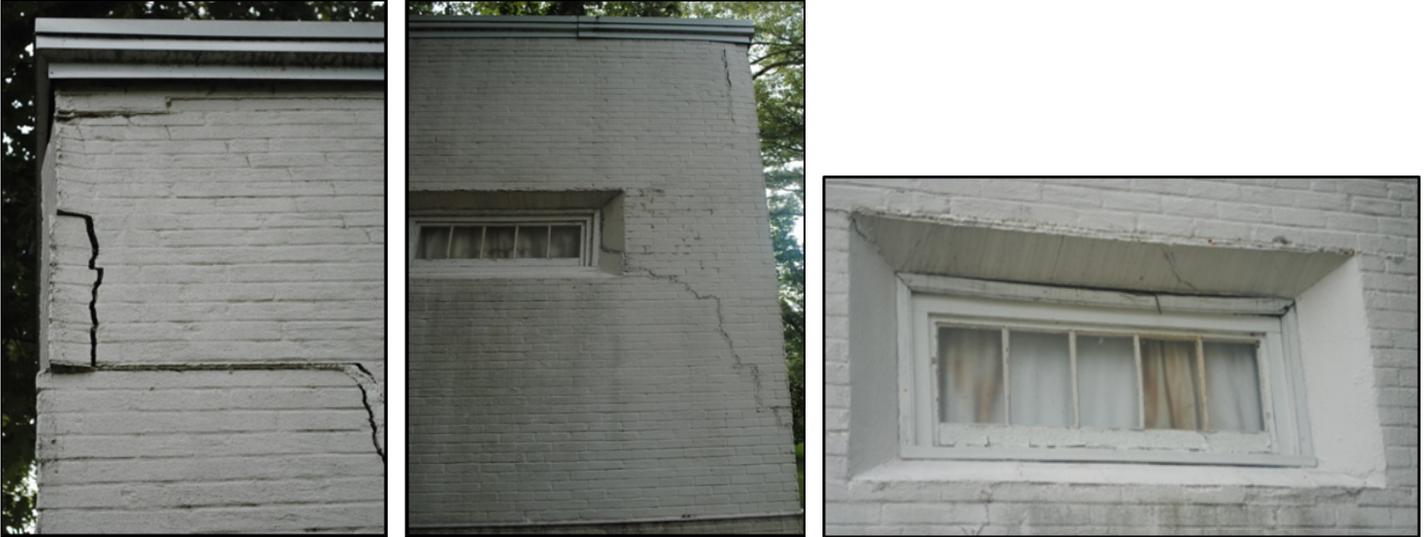
Deterioration of Exterior Building Envelope: (Structural Walls) Severe cracking and movement of the masonry walls is occurring in the southwestern corner of the museum building. The exterior wall coating is in need of new application. **(Windows)** The structure contains 22 windows with metal lintels that are in poor condition. Rusting and swelling of the metal lintels has caused drooping in the window opening and deterioration of the wood window units. **(Roof)** In slow rainstorm events, the flat roof leaks into the interior of the building.

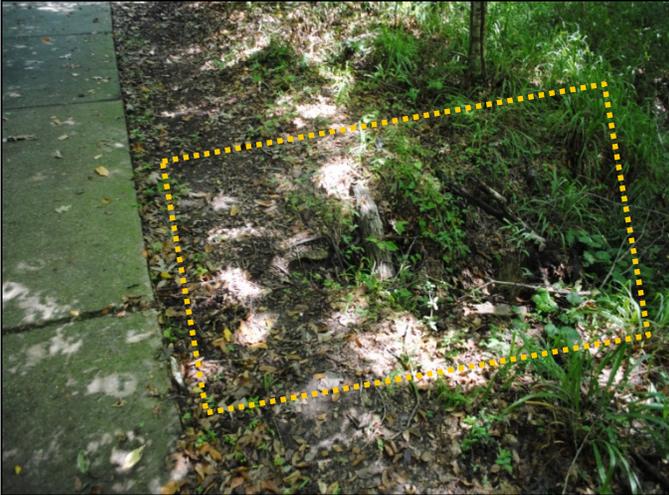
Runoff-Induced Erosion: Access trails throughout the park are eroding due to runoff and flooding events.

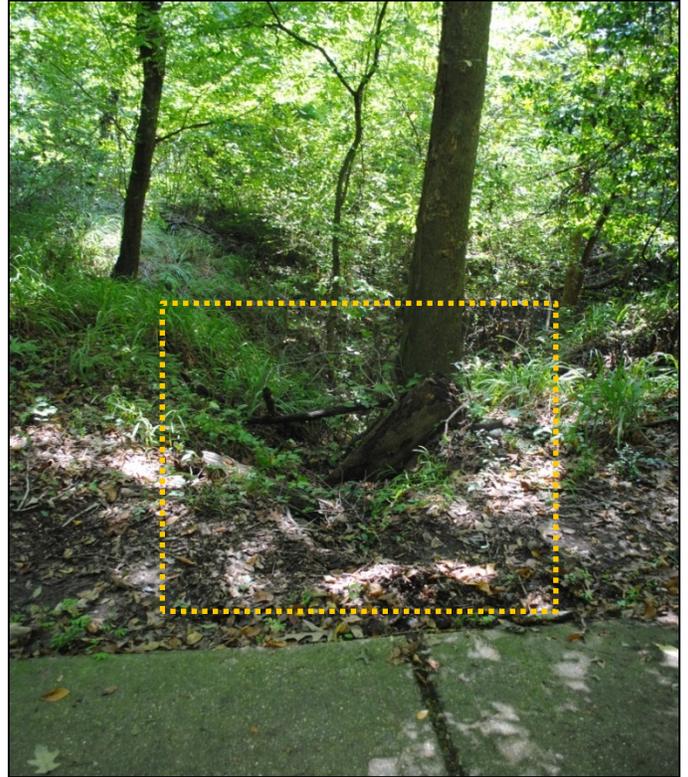
Property Located in SFHA:

Portions of the property fall in a Special Flood Hazard Area (SFHA) A zone. In previous floods, several bridges that connect access trails were washed away.

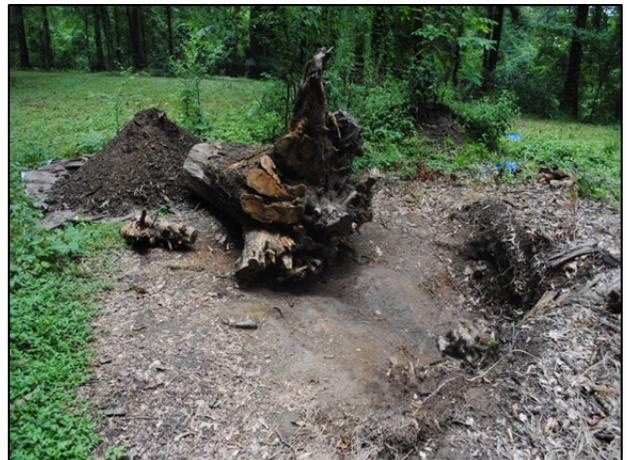
Large/Mature Trees: Most of the Poverty Point site is heavily wooded with trees that are prone to high winds and oversaturation of the ground. The root balls of mature trees create large holes in the landscape that must be filled and repaired, and the trees must be removed off site. Staff should perform selective cutting or removal of trees on the earthworks or near facilities housing historic artifacts.

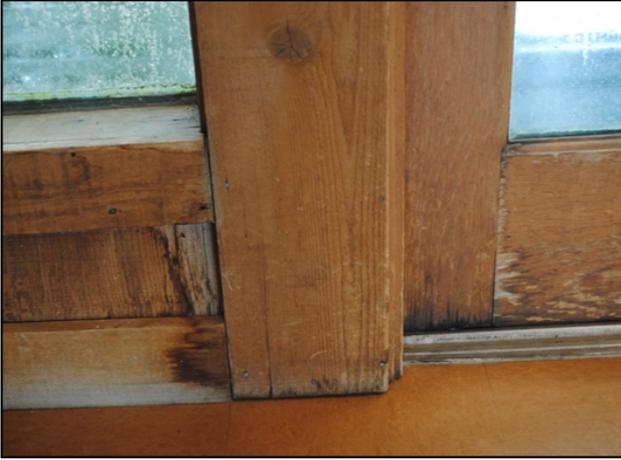
Deterioration of Exterior Openings: The exterior doors of the Visitor Center are in need of repair or replacement due to age and moisture damage.

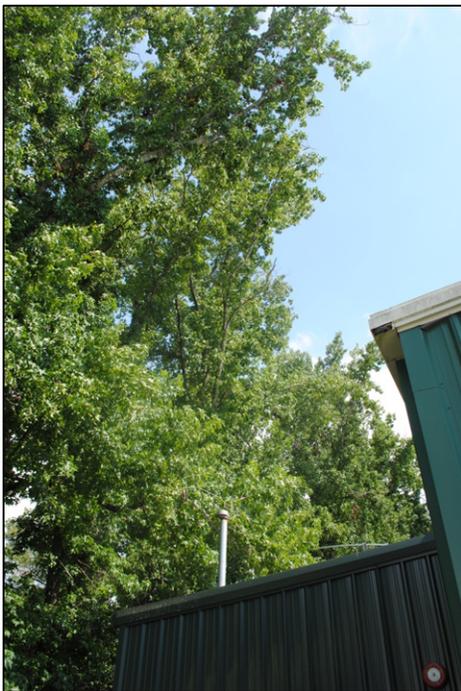
Large/Mature Tree Vulnerability: Several mature water oaks are situated directly behind the Curation Facility. Many similar trees have fallen throughout the site during past high-wind events. The subject trees could pose a hazard to the structure and its contents.

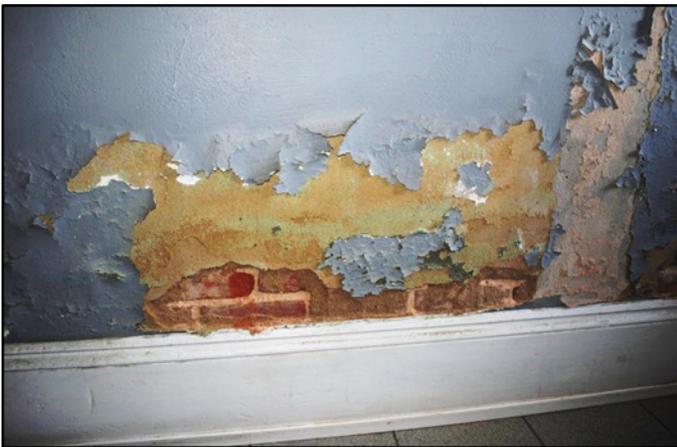
Interior Moisture Damage: Deterioration of the plaster application over brick structural walls was detected. Mortar joints should be tuck-pointed to prevent water intrusion (which causes moisture damage to the plaster) and to prevent brick failure (such as cracking).

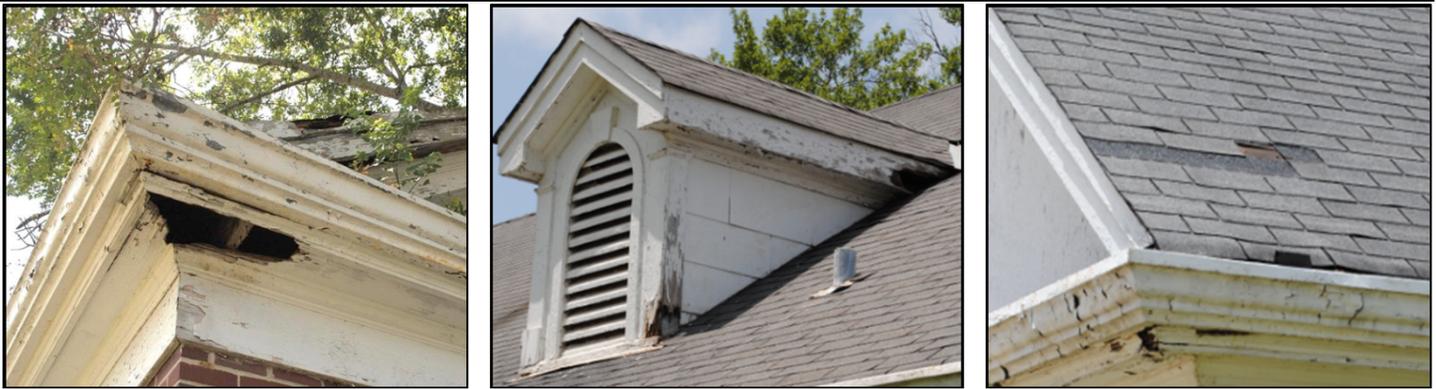
Deterioration of Exterior Building Envelope: Severe deterioration of the wood soffits, siding, and trim were observed. The roof covering has warped and is missing shingles throughout, exposing the roof deck underlayment. The windows and doors were graded to be in fair condition but are in need of replacement. Each of these vulnerabilities can cause moisture damage in the interior and induce mold growth—in a facility used for health care.

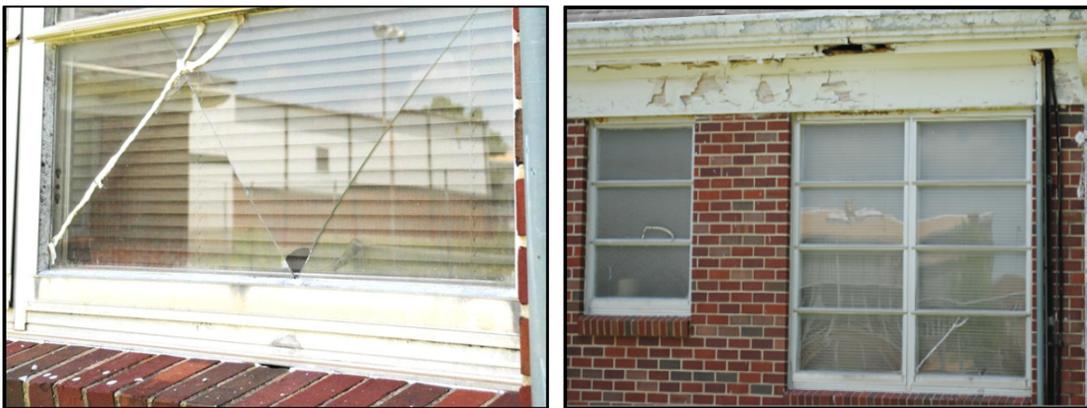
Broken Non-Impact Resistant Windows: Broken windows at the rear of the building were detected. Non-impact resistant windows are susceptible to water infiltration once broken.

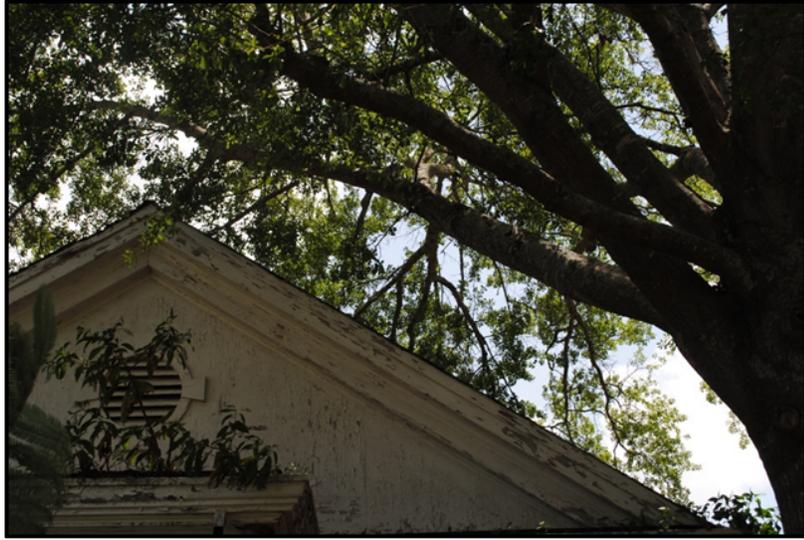
Overhanging Tree: Branches from an overhanging tree that are resting on a portion of the roof need to be trimmed. The subject tree is located in the rear of the property, approximately 1.5 feet away from the structure.

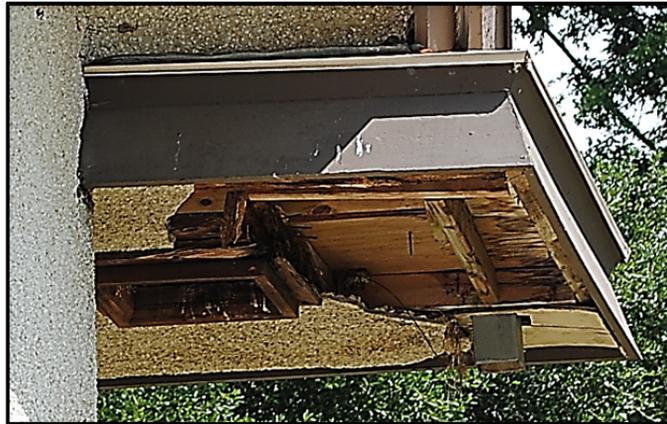
Deterioration of Exterior Building Envelope: Deterioration of the stucco cladding was detected at numerous locations around the soffit parameter, exposing the wood roof frame and sheathing to water damage.

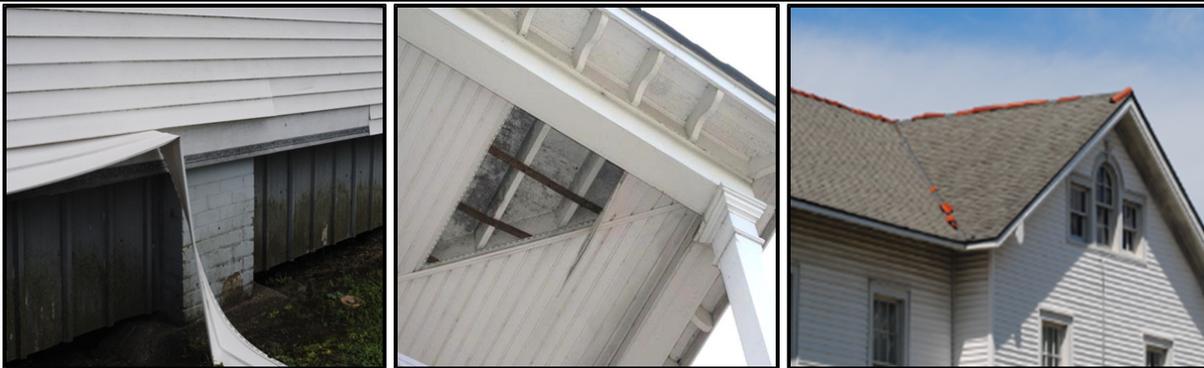
Exterior Building Envelope Damage: Missing/poorly attached siding and insufficiently attached ridge tiles were detected on the office/administration buildings. These items can become wind-borne debris sources during high-wind events, and failure of the building envelope material can lead to water infiltration into the interior portion of the structure.

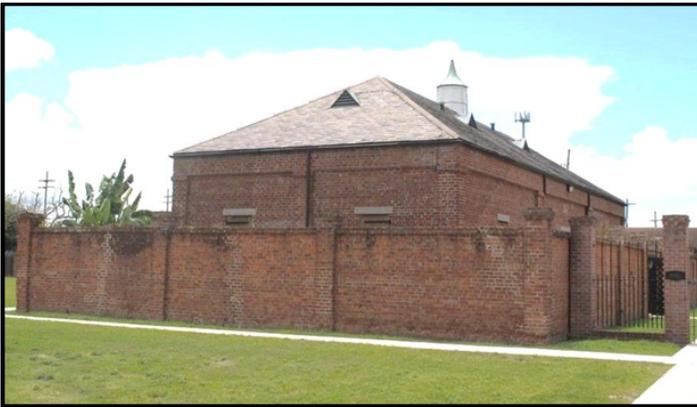
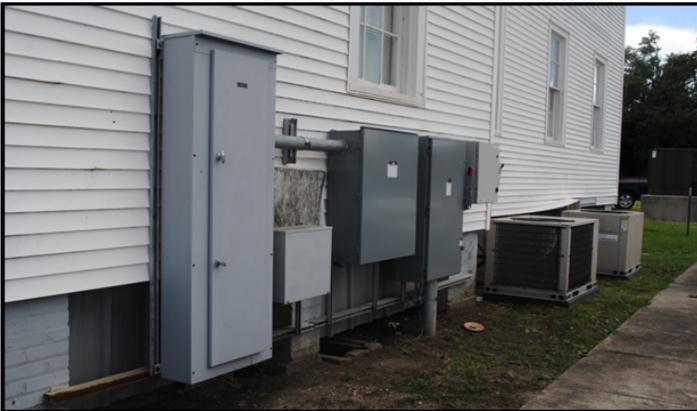
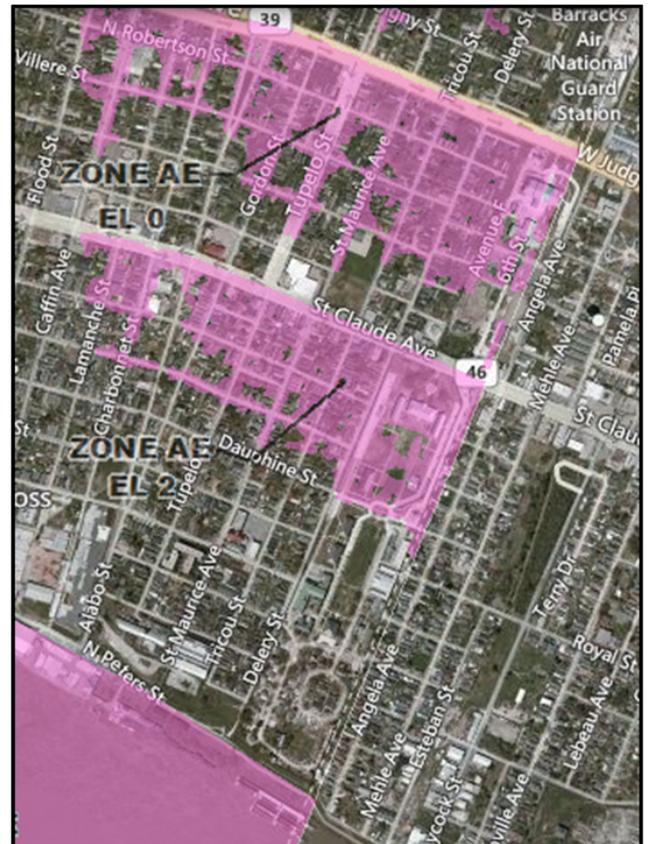
Campus within Special Flood Hazard Area (SFHA)/Flood History: Although the historic buildings that were assessed were not in the SFHA, portions of the Jackson Barracks campus do fall in the SFHA AE Zone. Moreover, the subject buildings sustained substantial flood damage during Hurricane Katrina, measuring up to 8 feet in some areas.

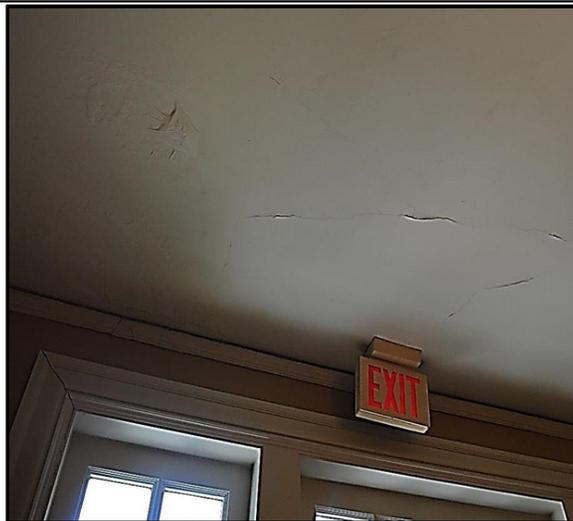
Interior Moisture Damage & Possible Roof Ponding:

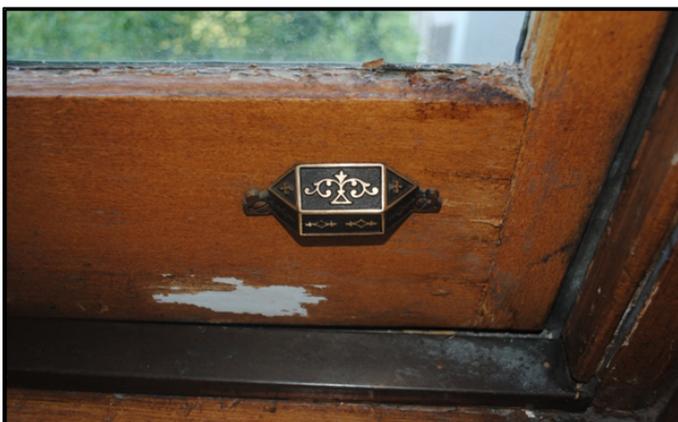
Deterioration of Non-Impact Resistant Windows: Many of the windows were reported to have insufficient insulation and/or sealing, causing water intrusion of wind-driven rain. If left unattended during a major rain event, the windows can cause damage to wood floors, draperies, or furniture. Non-impact resistant windows are susceptible to water infiltration once broken.

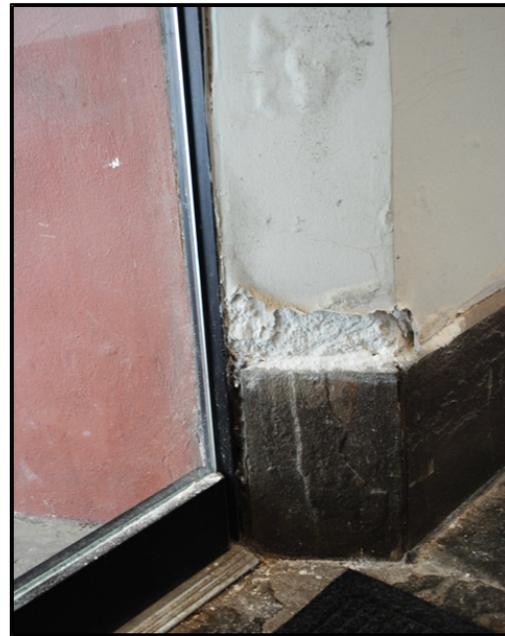
Interior Moisture Damage: Deterioration of the plaster application over the brick structural walls was detected. Mortar joints should be tuck-pointed to prevent water intrusion (which causes moisture damage to the plaster) and to prevent brick failure (such as cracking).

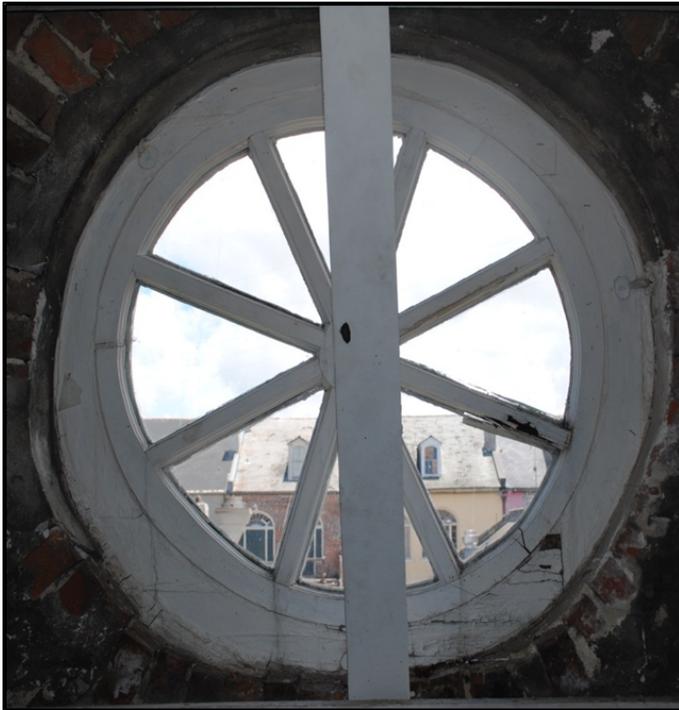
Non-Impact Resistant Windows: Non-impact resistant windows (single pane/annealed) are susceptible to water infiltration once broken. Leaking can occur between glazing, window frames, and exterior walls due to flashing, sealant, or gasket failure.

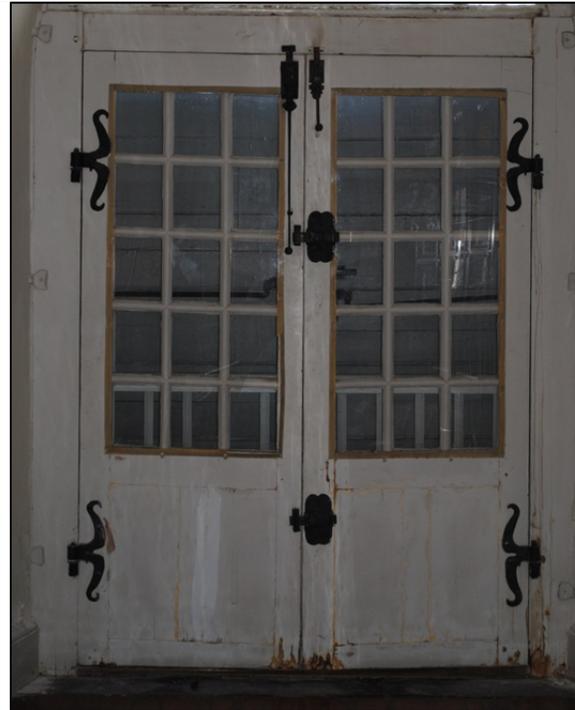
Condition of Non-Impact Resistant Glass Windows and Doors Frames: Deterioration of the most of window frames and second floor French doors was observed. Moisture intrusion, from wind-driven rain and humidity, will cause further deterioration to the opening systems. It could also cause water intrusion in the interior of the building. Window protection for non-impact resistant glass units should be used in the case of high-wind events because such windows are susceptible to water infiltration once broken.

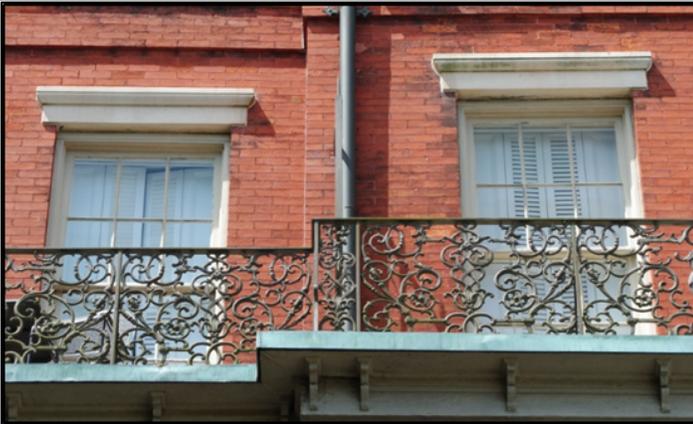
Non-Impact Resistant Windows: Non-impact resistant windows are susceptible to water infiltration once broken. It is recommended that window protection be used in a high-wind event.

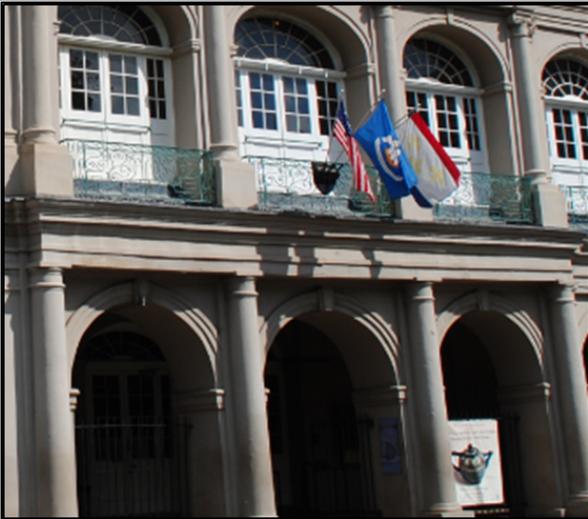
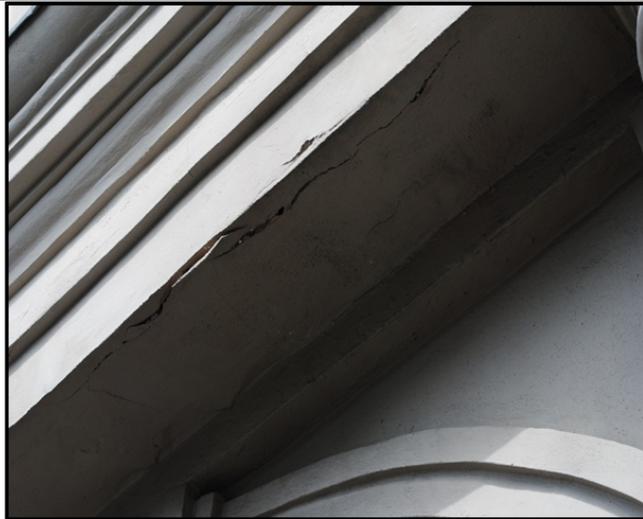
Moisture Damage to the Exterior Building Envelope Damage: Deterioration to the front building façade was detected. The damage was reportedly caused during Hurricane Isaac in 2012. Mortar joints should be tuck-pointed to prevent water intrusion (which causes moisture damage to the plaster) and to prevent brick failure (such as cracking).

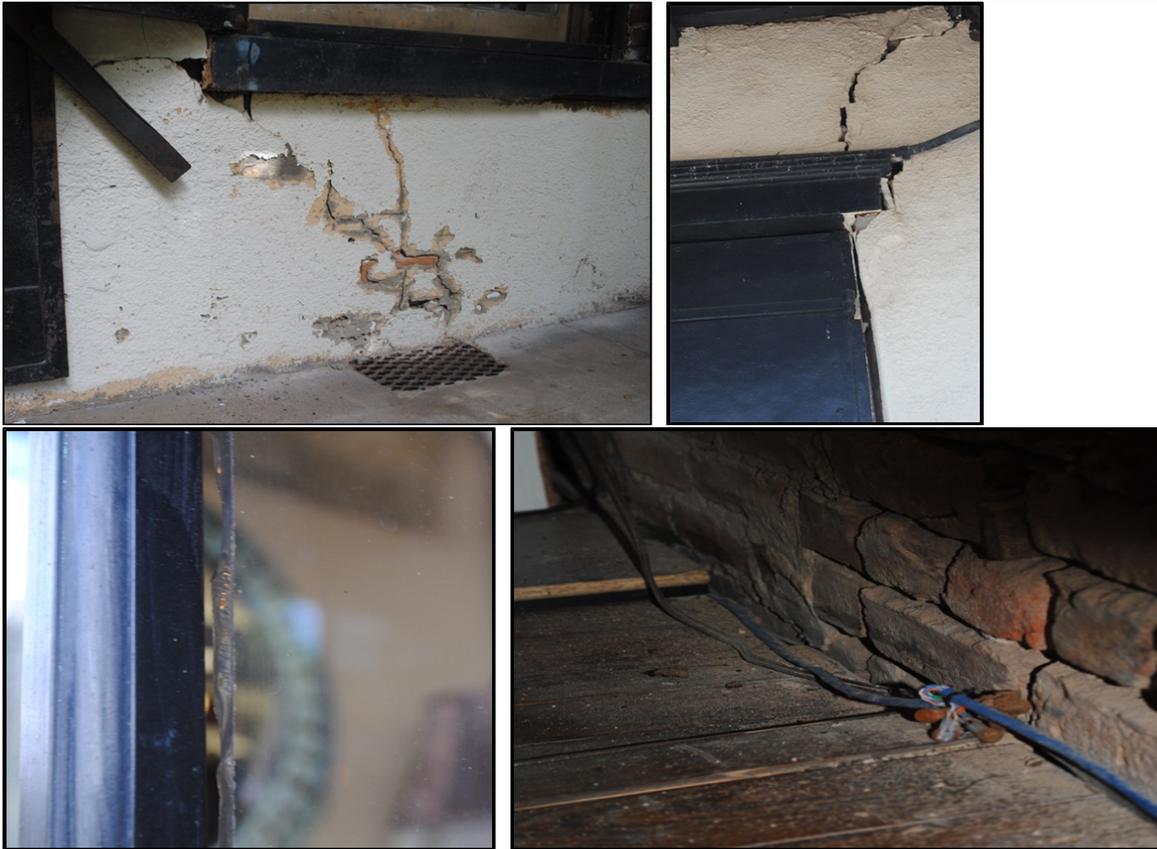
Cracks in Structural Walls: Large cracks were found at numerous locations on the south- and west-facing exterior masonry walls. At the bottom of the south-facing masonry wall, a half inch gap between the wall and the flooring material was observed, suggesting that the wall has moved outward over time. A large gap between the glass and frame of the storefront window display also suggests movement of the structure. The second floor interior was not assessed, since it has never been repaired after a 1970s fire. An exterior assessment of the second floor further confirmed that the south-facing exterior wall has moved outward, causing severe cracks in the structural wall.

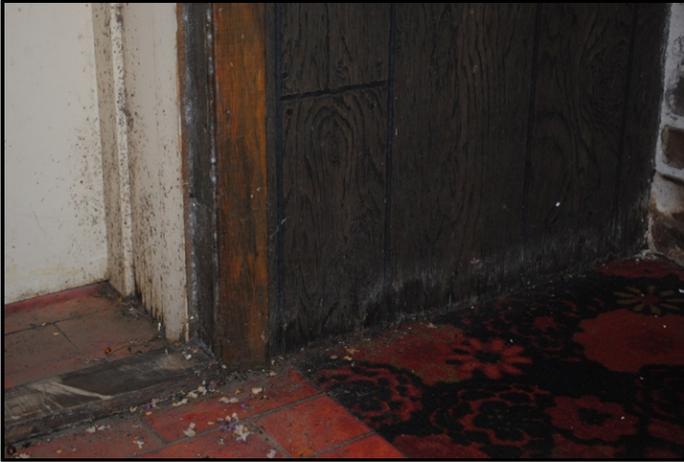
Flooding Inside Structure: The storeroom attached to the back of the main structure has experienced flooding due to drainage problems in the back of the property. A 1.5-inch water line and mold damage was discovered. Numerous buildings along Front St. have had flooding issues from the same source, and these episodes seem to be precipitated by periods of heavy rainfall. Drainage improvement projects should be explored to prevent further flooding events.

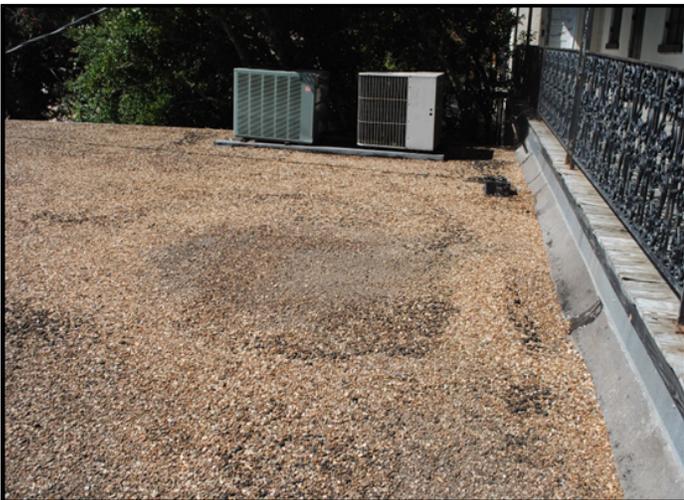
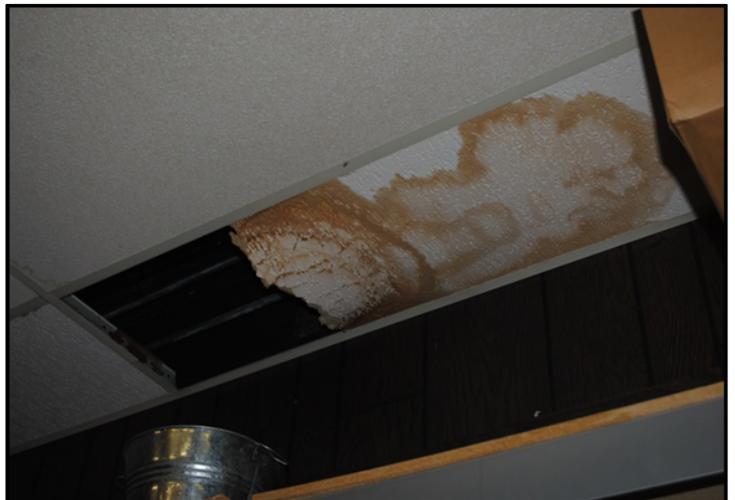
Roof Leak and Evidence of Ponding: A frequent roof leak in the back portion of the building is most likely attributable to the ponding issue detected on the built-up roof system. The roof covering appears to be in fair-poor condition and should be replaced in the near future.

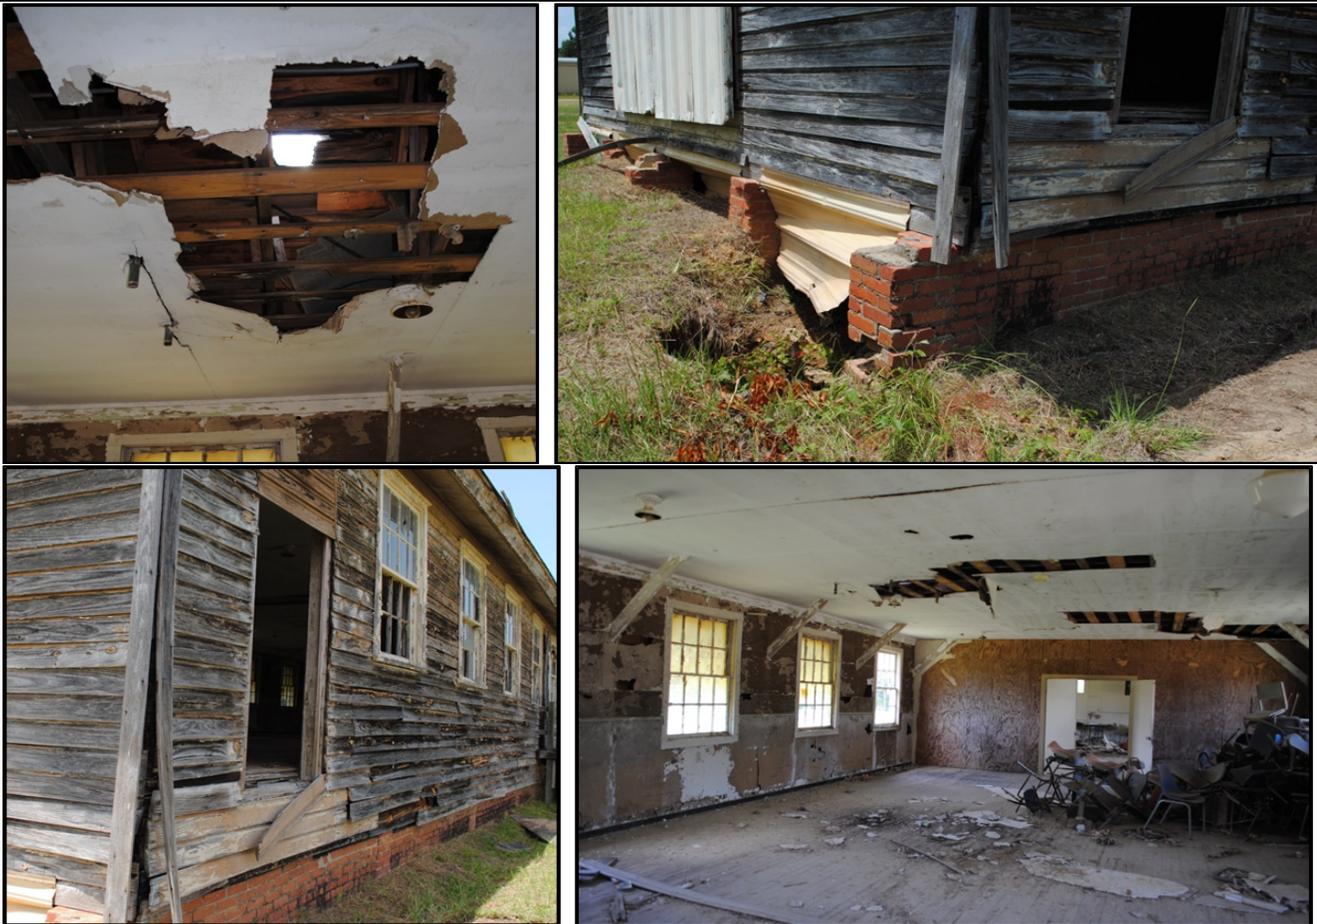
Building Condition: While there are two remaining P.O.W. Camp buildings on-site, one was severely damaged and partially crushed by a fallen tree and was not chosen for the assessment. The unharmed building, pictured above, is still intact with original fixtures, but it is in severe condition due to years of neglect. The damages are as follows: large hole in the roof covering; holes in the ceiling; no exterior door; broken windows; deterioration of wood siding; large sinkhole at southern end of the foundation; foundation damage; and water damage to interior walls and wood floors.

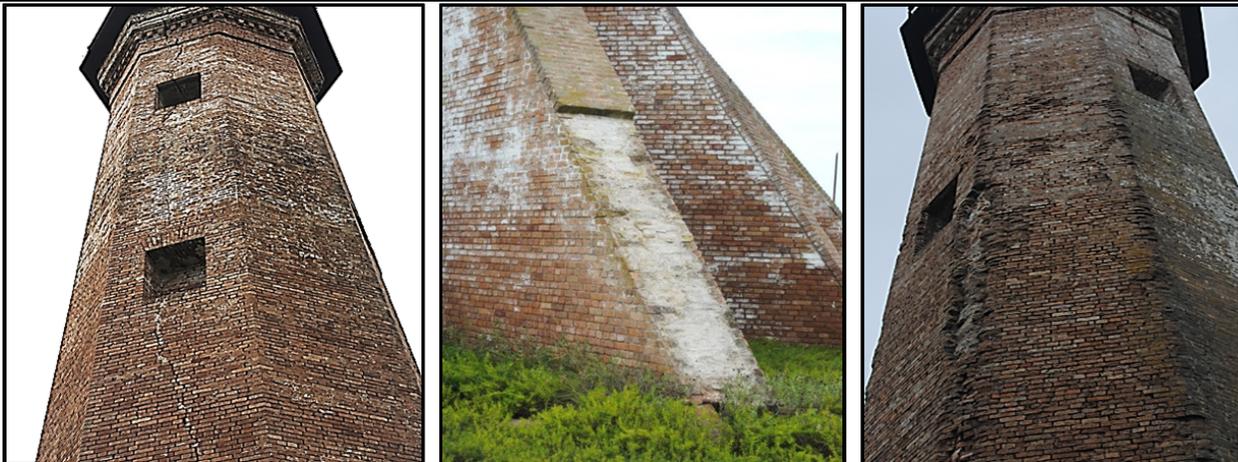
Cracks and Deterioration in Structural Walls: A large crack (estimated 20 feet in length) was found on the southern face of the structure. Motor deterioration has caused some masonry units to fall off the structure, especially on the buttresses and corners of the octagonal walls. Mortar joints should be tuck-pointed to prevent further brick failure and cracking.

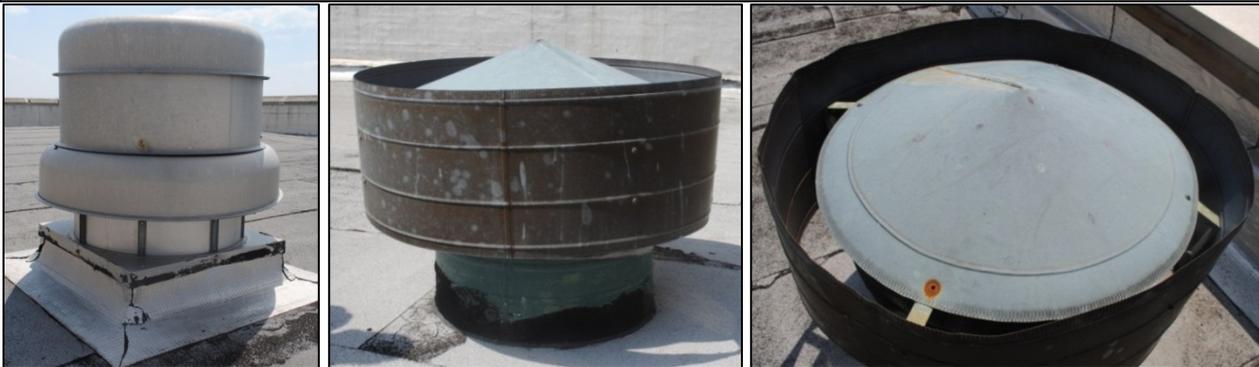
Insufficient Attachment of Fan Cowlings and Fan Base to Roof Curb: Attach exhaust fans and air intakes to the curb with corrosion resistant fasteners not exceeding 6 inches on center between the equipment, transition pieces, and the roof curb. Fan cowlings should be attached to the curb with steel cables. Two cables are recommended for areas with less than 120 mph wind speed and cowlings less than 4 feet in diameter, 1/8-inch-diameter stainless steel cables are recommended.

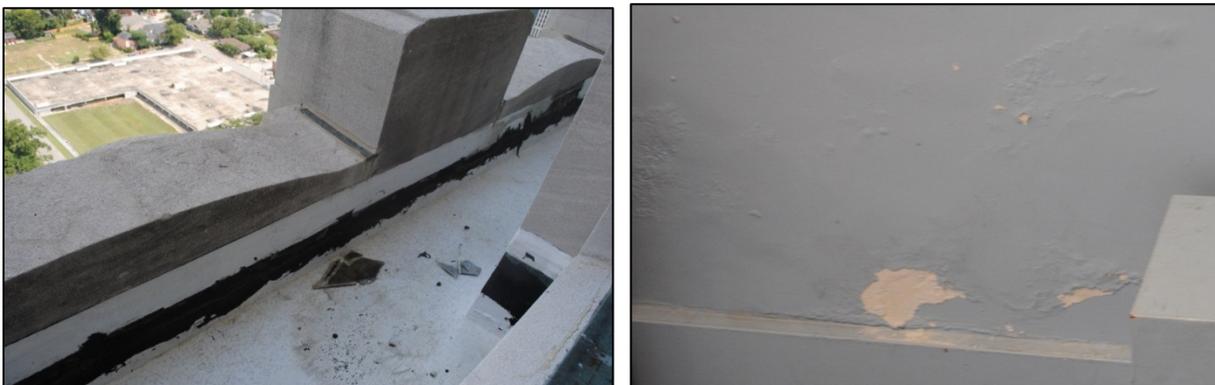
Interior Moisture Damage: Moisture damage to the interior plaster walls was detected on several floors of the structure. It is recommended that flashing around the ledges be repaired to prevent wind driven rain intrusion.

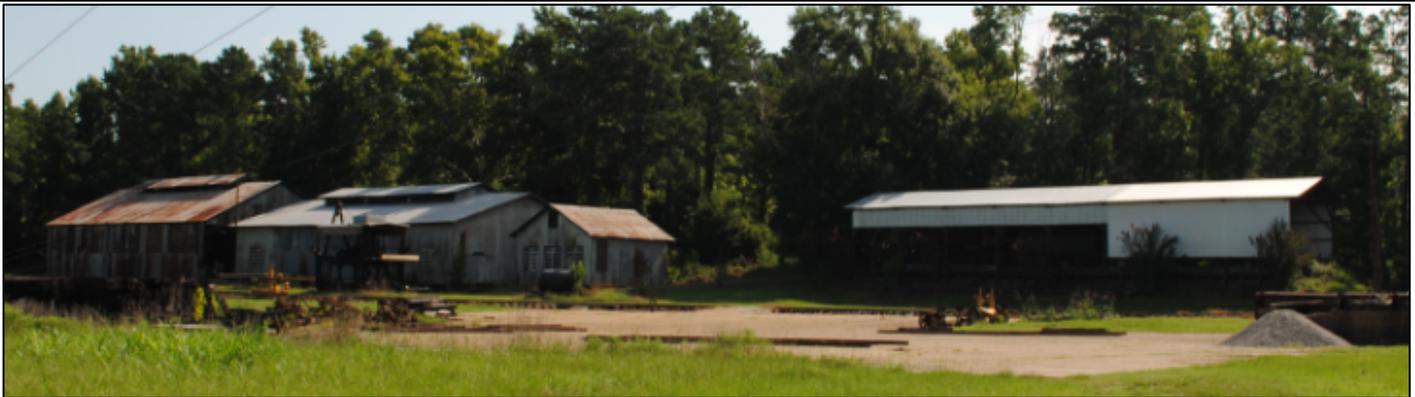
Erosion of Foundation: Storm water runoff from an uphill area is eroding and destabilizing the soil at the base of the machine shop, round house, and car knocker shed. As a result, the foundations are being undermined, threatening the stability of the structures.

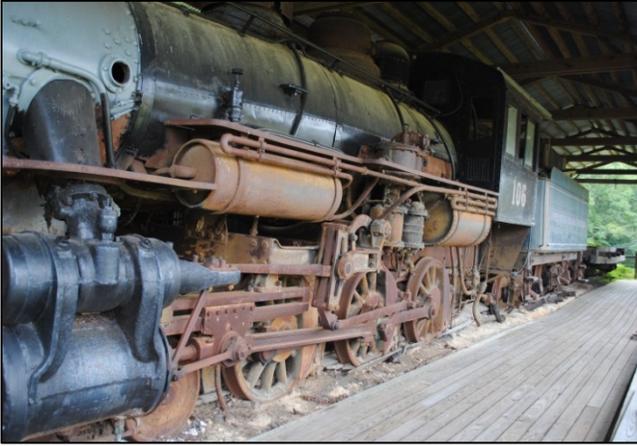
Foundation Issue: The foundation the antique steam engine sits on appears to be sinking. The train car is situated atop a hill that may be sloughing off due to runoff.

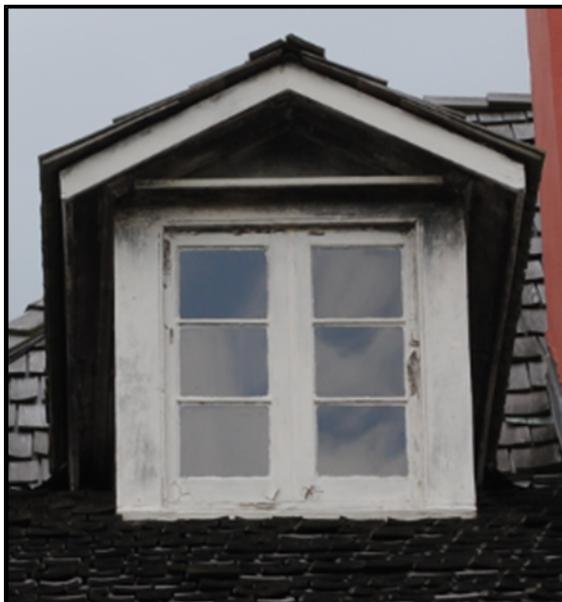
Condition of Non-Impact Resistant Windows: Deterioration of the dormer window frames was observed. Window protection should be used in the case of high-wind events because non-impact resistant windows are susceptible to water infiltration once broken.

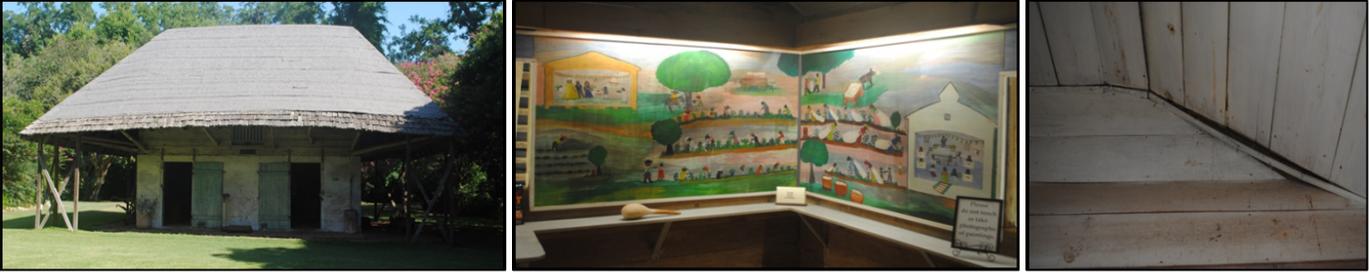
Protection of Wall Murals: The second floor of the Africa House includes painted wall murals by local folk artist Clementine Hunter. These murals are vulnerable to wind-driven rain, through the second story windows and roof. Water damage was detected on the ceilings and walls of the room housing the murals. Plantation caretakers feel that a plastic covering, or equivalent, that would either wrap around the second floor or cover the murals, during prolonged rain events, would provide sufficient protection.

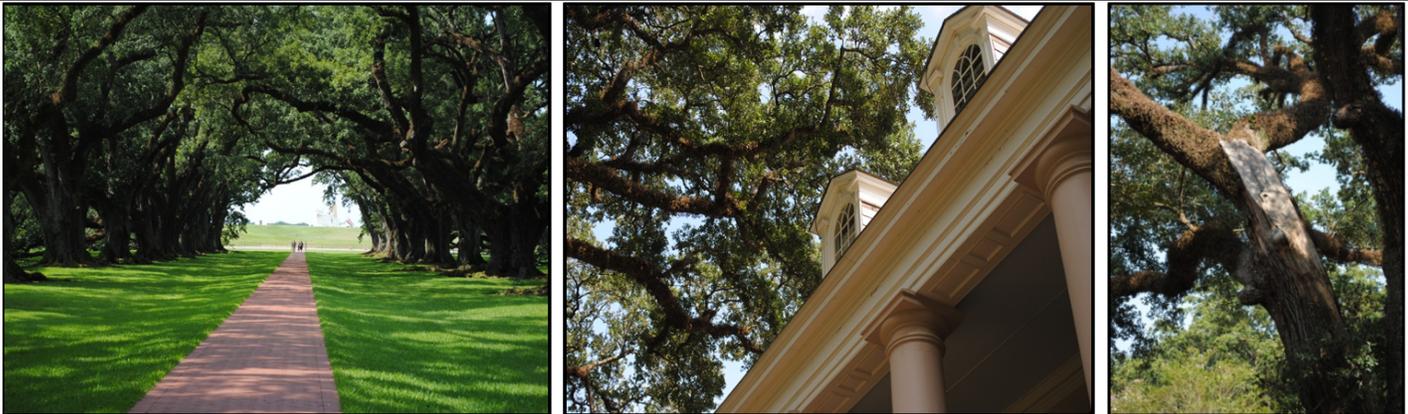
Tree Protection: Oak Alley is famous for its Heritage live oak trees that reside on the property, especially those that line the alley walkway to the front entrance of the plantation. The lightning protection systems of individual trees were severely damaged during Hurricane Gustav, and seven unprotected trees are in need of lightning protection installation. Currently the subject trees are at risk of injury or death from a lightning strike.

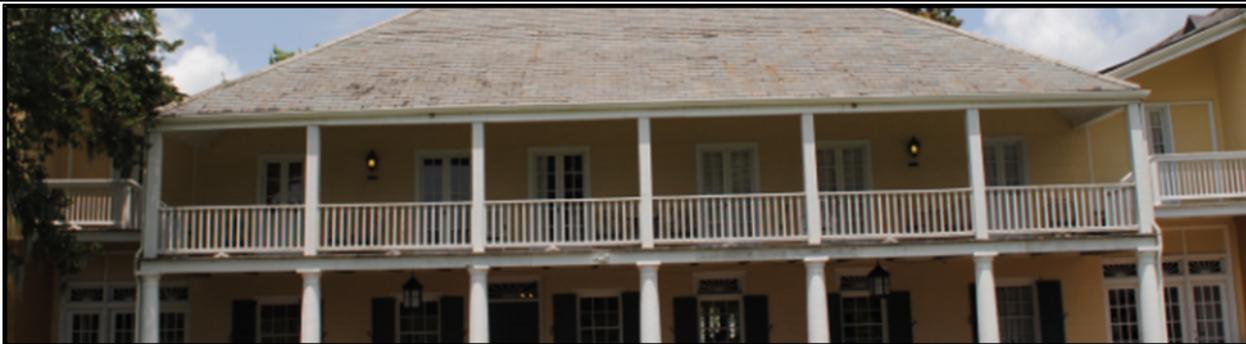
Opening Protection: The French doors, located on the second and first story, have a history of blowing open during high-wind events. It is recommended that wind-rated plantation shutters be installed for use.

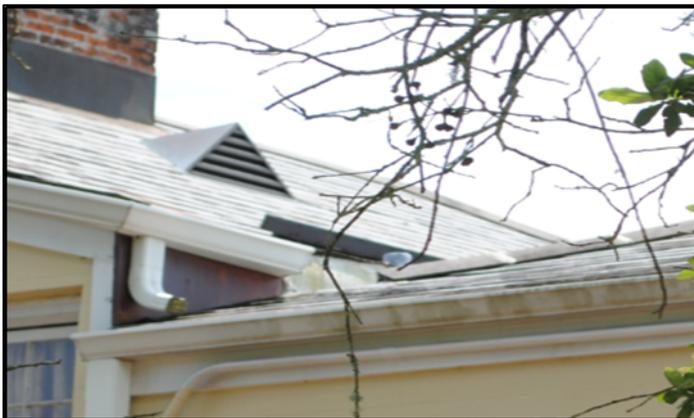
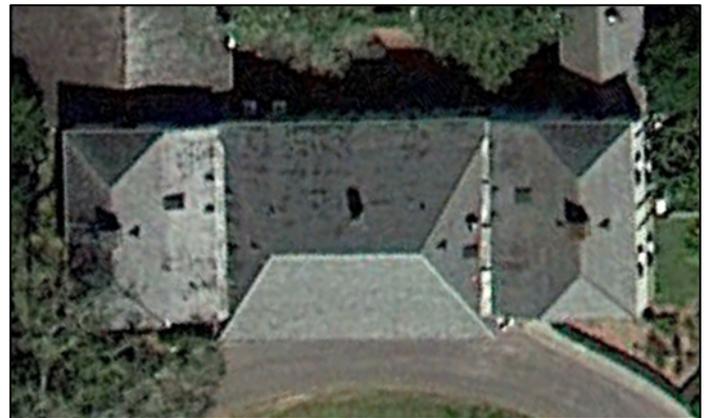
Latch Mechanism Failure: Roof hatches have a history of blowing open, during high-wind events, subjecting the interior to rain infiltration.

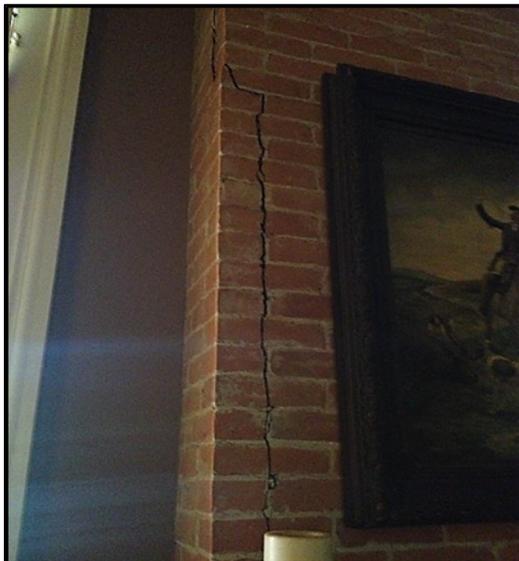
Crack in Masonry Fireplace: A large crack was found on the front-facing fireplace.

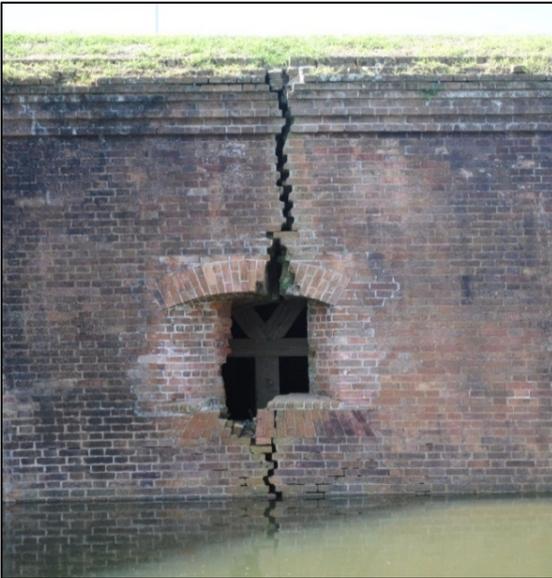
Cracking and Movement of Structural Walls and Water Intrusion: Severe cracking of masonry walls was observed on the corners of the structure and at window openings. Standing water was present in the rooms facing the open waterway. Deterioration of the brick and mortar was severe in numerous areas. This structure sustained substantial damage from storm surge during Hurricanes Katrina and Isaac.

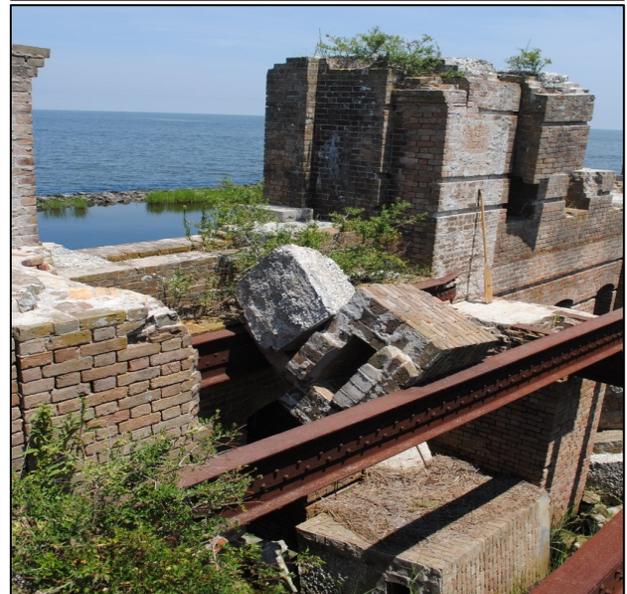
Coastal Erosion, Subsidence, Wind, and Storm Surge Damage: Fort Proctor is in serious disrepair and is currently inundated by 1.5 feet of water. Many of the second story masonry walls have collapsed and have fallen to the ground floor, presumably from hurricane wind and storm surge damage. With increased sea level rise, active coastal erosion, and subsidence issues, increased inundation of the ground floor is expected.

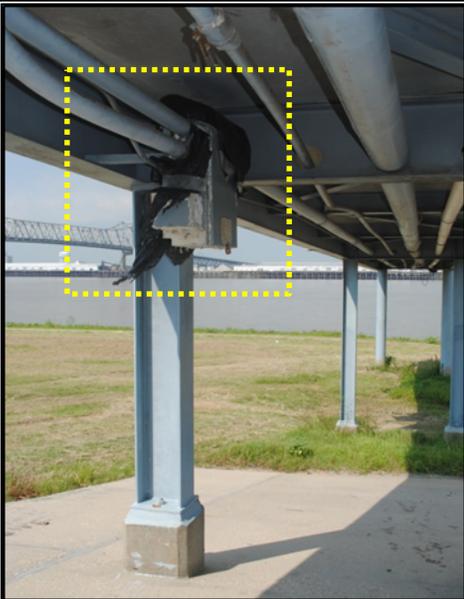
Flood Hazard: An electrical junction box that provides power to the *USS Kidd*, located underneath the walkway used to access the ship, is subject to damage when flood events occur. In past inundation events, repair has cost several thousand dollars. It is recommended that the junction box be re-located to a higher elevation.

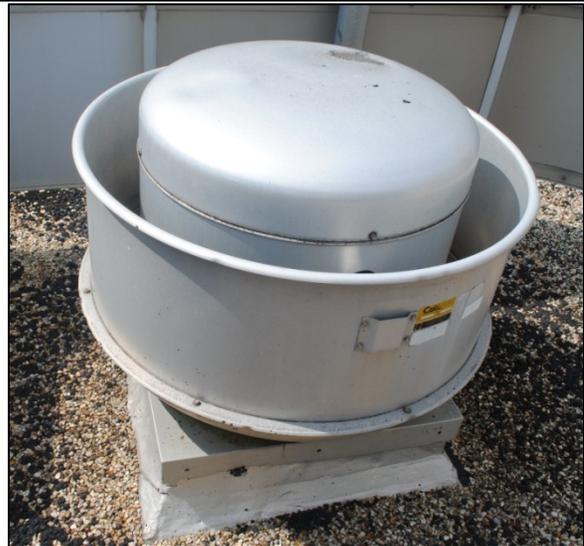
Insufficient Attachment of Fan Cowls and Fan Base to Roof Curb: The exhaust fans were observed to have no mechanically screwed attachments to the roof curb. Exhaust fans and air intakes should be attached to the curb with corrosion resistant fasteners not exceeding 6 inches on center between the equipment, transition pieces, and the roof curb. Fan cowlings should be attached to the curb with steel cables. Two cables are recommended for areas with less than 120 mph wind speed and cowlings less than four feet in diameter, 1/8-inch-diameter stainless steel cables are recommended.

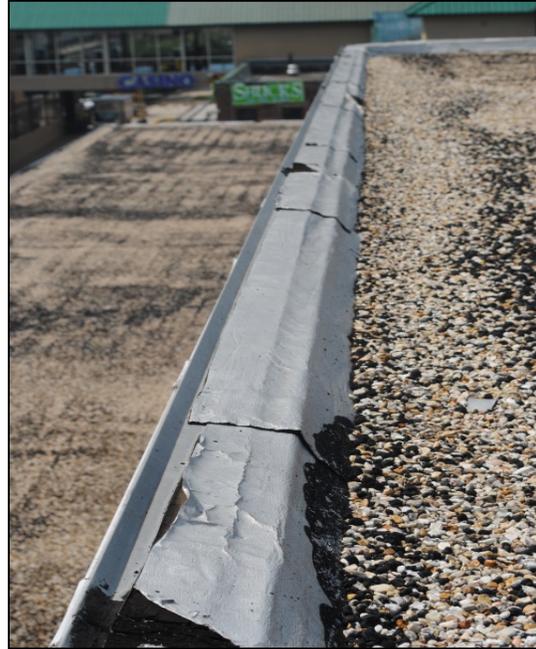
Roof Condition: The built-up roof system and flashing were found to be in fair condition. Loose aggregate was found throughout the rooftop and can become wind-borne debris sources in a high-wind event. Flashing atop the penthouse needs to be repaired to prevent water intrusion.
