3. STATE HISTORICAL PROPERTIES RISK ASSESSMENT

INTRODUCTION

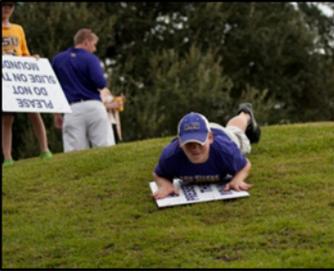
Erosion of Historic Earthworks: The LSU Campus Mounds have experienced 6,000 years of natural erosion, but they are also being damaged by human activity, primarily during LSU football games. University officials have stated that “the mounds have suffered internal structural damage that would lead to their eventual collapse.” In 2010, temporary fencing was used during football weekends to prevent access to the mounds. The fencing was quickly torn down by tailgaters, however. Permanent fencing may be considered to restrict human activity on the mounds.

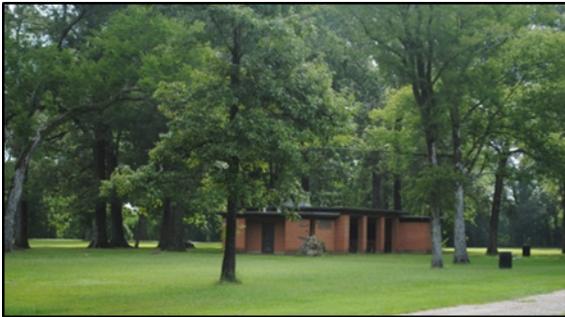
Large/Mature Trees: Thirty large oaks were lost during Hurricane Gustav. Large water oaks, which have shallow root systems and are vulnerable to uprooting during high-wind events and slumping in waterlogged conditions, are near the museum structure and surround another structure on the property.

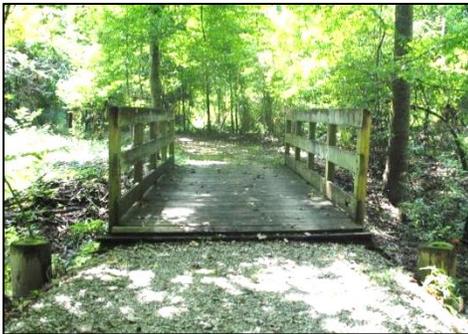
Property Located in SFHA:

Portions of the property fall in a Special Flood Hazard Area (SFHA) A zone. In previous floods, several bridges that connect access trails were washed away.

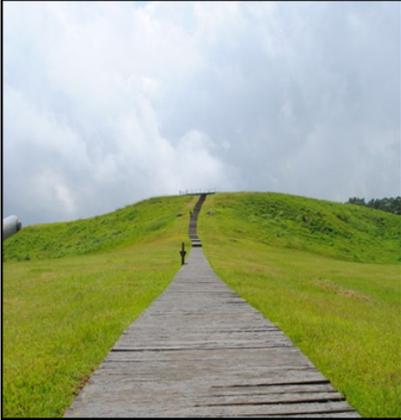
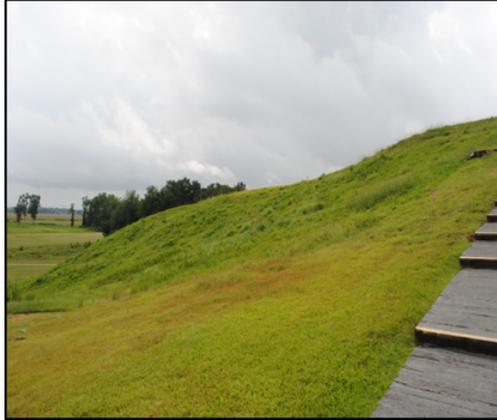
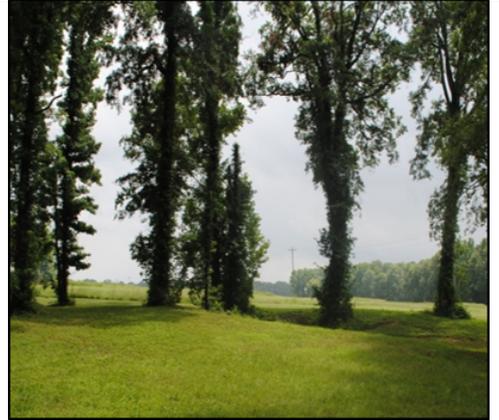
Erosion of Earthworks: The Poverty Point earthworks have undergone over 3,000 years of erosion. They were even used as farmland in the nineteenth and twentieth centuries, significantly decreasing the height of the original mounds and elliptical ridges. Rain runoff, mature tree growth, and armadillo holes (which retain water and cause slumping) are common problems that the park must solve to reduce further erosion.

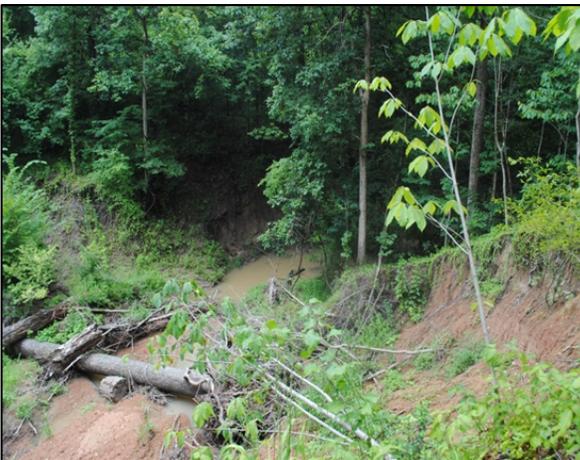
Runoff-Induced Erosion: Increased runoff into a tributary that joins Bayou Macon has caused landslides to a portion of Ridge 6 and the property housing the archaeological research center. According to the Poverty Point Park manager, increased runoff is likely due to neighboring farms that have altered the landscape.

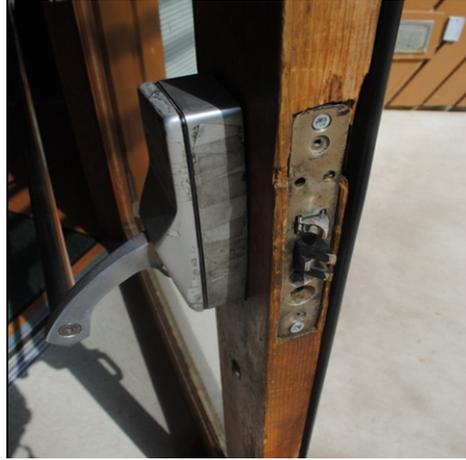
Deterioration of Exterior Openings: The exterior doors of the Visitor Center are in need of repair or replacement due to age and moisture damage.

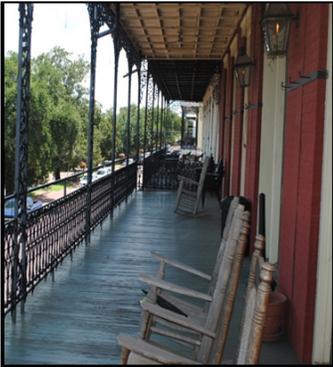
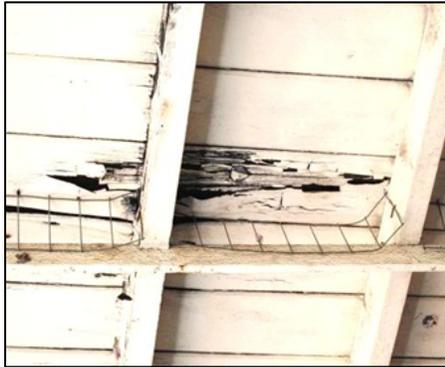
Roof Decking Deterioration: Deterioration of the wood-plank roof decking was detected throughout the span of the front porch. Some of this decking damage occurred at rafter connections, which could pose issues for that portion of the roof structure.

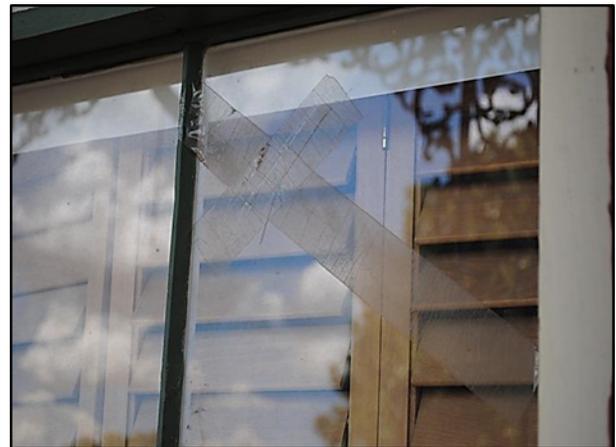
Non-Impact Resistant Windows: Non-impact resistant windows are susceptible to water infiltration once broken.

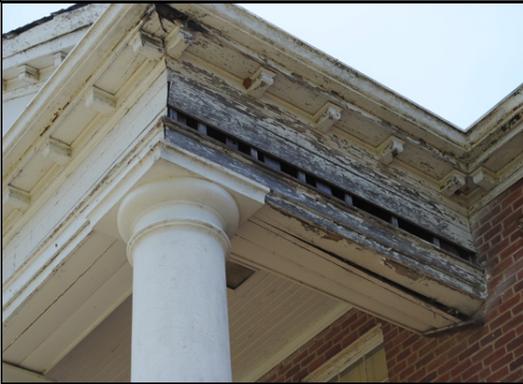
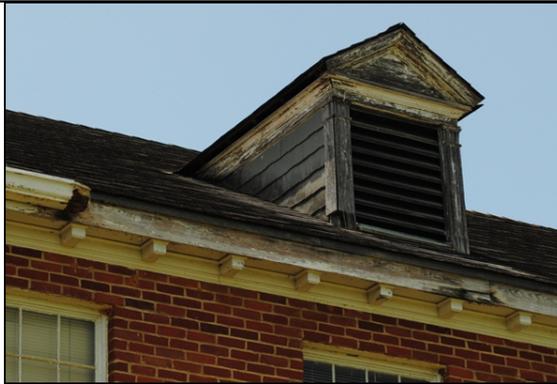
Deterioration of Exterior Building Envelope: Exterior wood siding (specifically used on the dormers, soffits, and fascia perimeter) is in need of replacement.

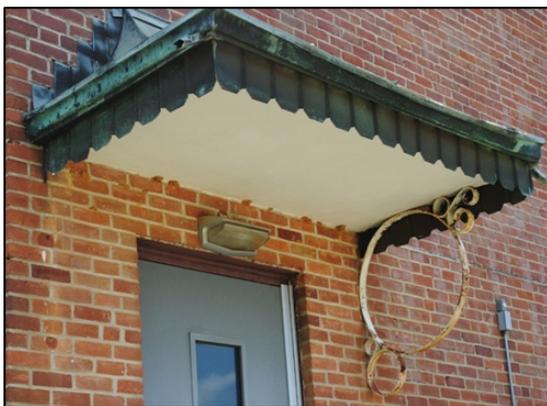
Insufficient Attachment of Non-Structural Building Features: Metal awning supports are deteriorated (one was missing on the north side of the building). Missing/broken gutters were also observed.

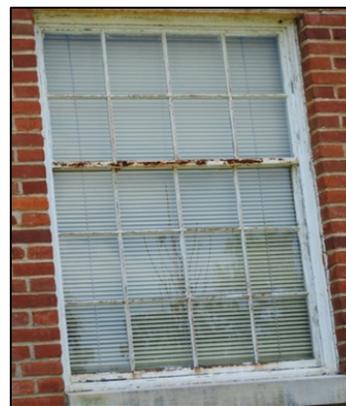
Condition of Non-Impact Resistant Windows: Deterioration of the window frames can lead to leaking between glazing, window frames, and exterior walls due to flashing, sealant, or gasket failure. Non-impact resistant windows are susceptible to water infiltration once broken.

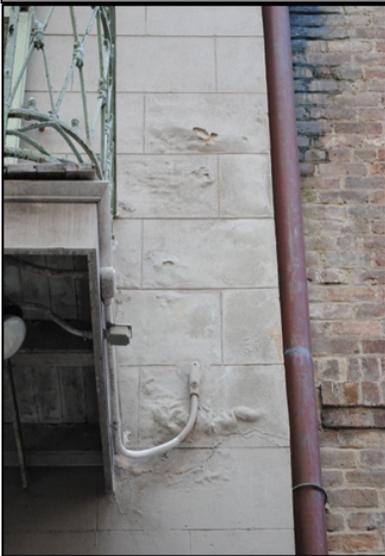
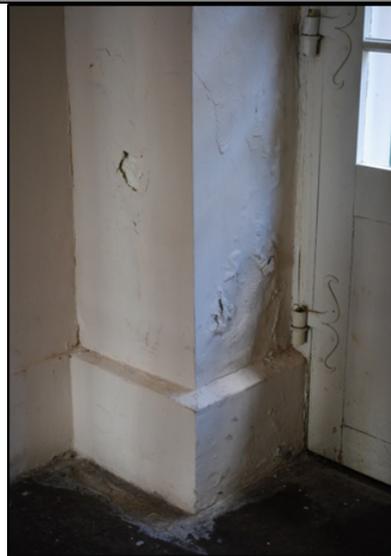
Moisture Damage to the Exterior Building Envelope: Mortar joints should be tuck-pointed to prevent water intrusion (which causes moisture damage to the plaster) and to prevent brick failure (such as cracking)

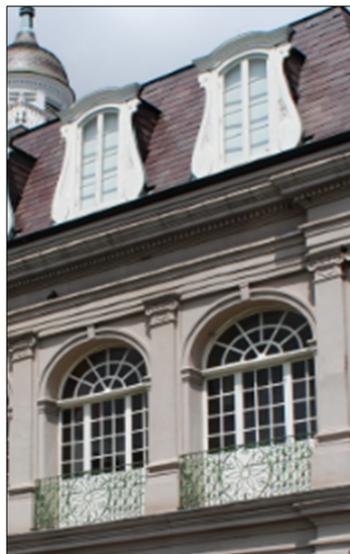
Vulnerable Openings: During Hurricane Isaac, the gallery doors facing Jackson Square, as well as the dormer windows facing Pirate’s Alley, blew open, causing interior damage from wind-driven rain. Exterior window and door protection should be used in the case of high-wind events, to prevent opening and breakage of the non-impact resistant glass units.

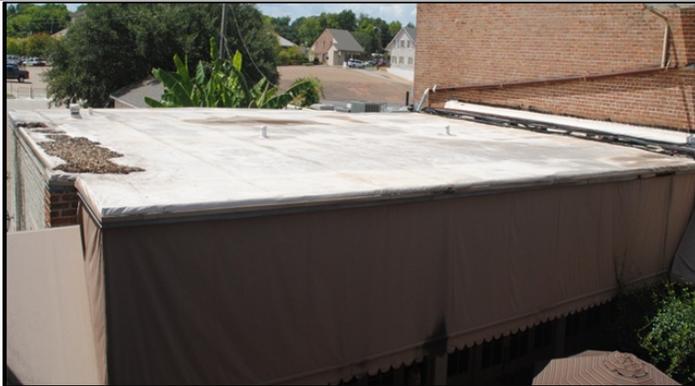
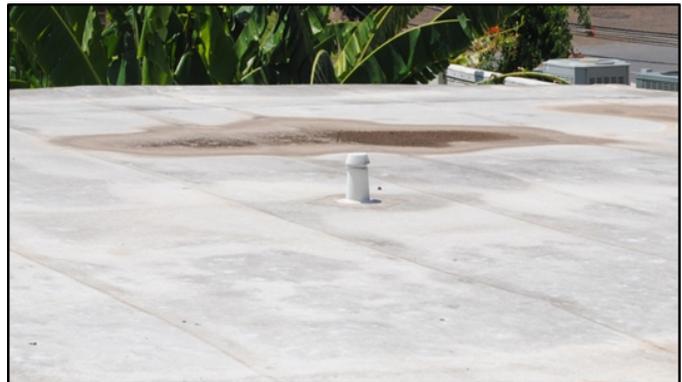
Ponding Issue: Ponding was detected on the carriage house in the rear of the property. Tree debris should be removed from the roof to prevent the restriction of rain runoff, and supplemental roof drainage should be considered for use.

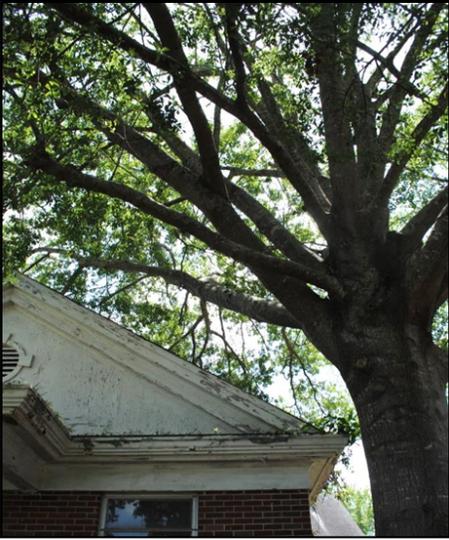
Overhanging Tree: Branches from an overhanging tree that are resting on a portion of the roof need to be trimmed. The subject tree is located in the rear of the property, approximately 1.5 feet away from the structure.

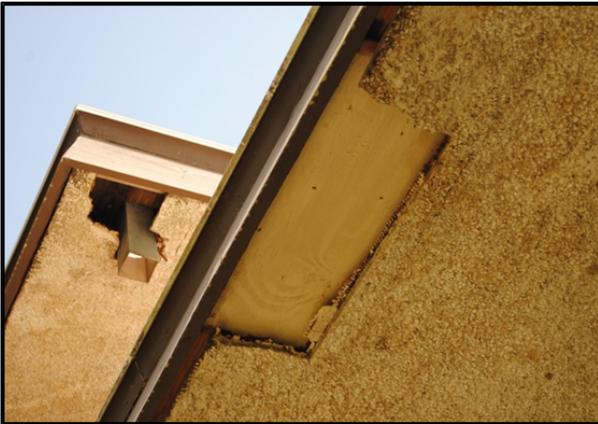
Deterioration of Exterior Building Envelope: Deterioration of the stucco cladding was detected at numerous locations around the soffit parameter, exposing the wood roof frame and sheathing to water damage.

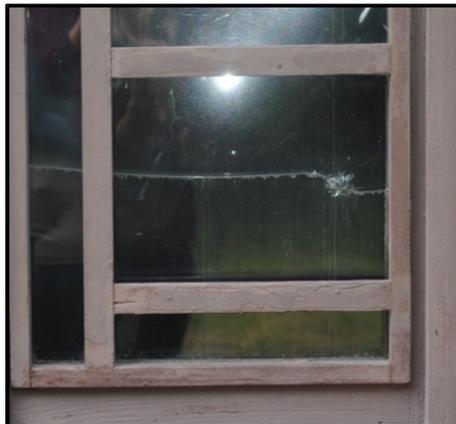
Non-Impact Resistant Windows:

A cracked glass pane was observed on the southern side of the structure.

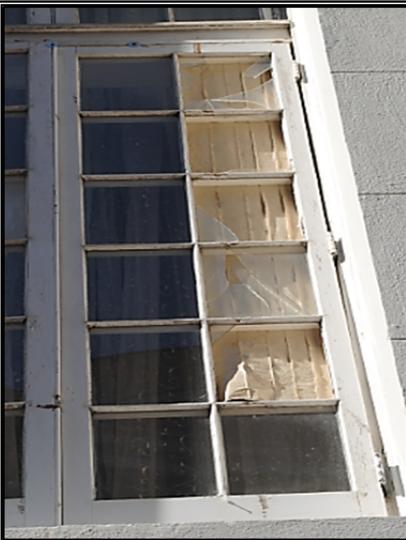
Window Protection for Non-Impact Resistant Windows & Condition of Openings:

Several broken windows were found throughout the structure. Window protection should be used in the case of high-wind events because non-impact resistant windows are susceptible to water infiltration once broken.

Exterior doors to the basement portion of the structure were found to be in fair-poor condition, which could lead to wind-driven rain intrusion or opening during high-wind events.

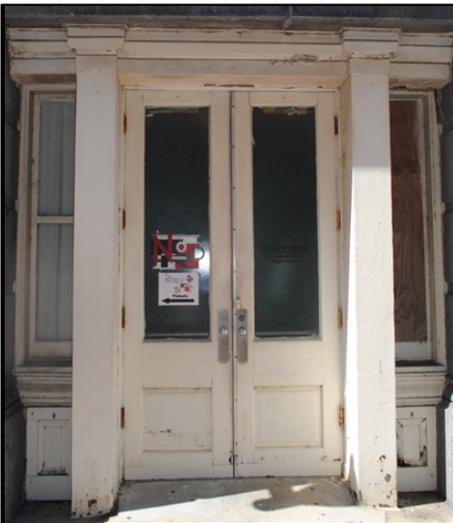
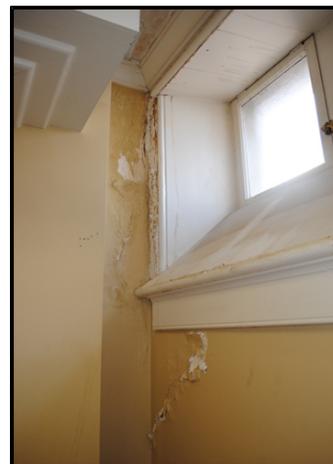
Moisture Damage: Moisture damage was detected on numerous interior walls throughout the building.

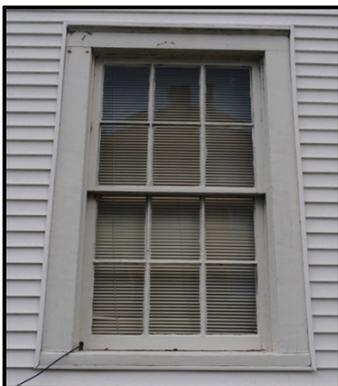
Window Protection for Non-Impact Resistant Windows: Window protection should be used in the case of high-wind events because non-impact resistant windows are susceptible to water infiltration once broken.

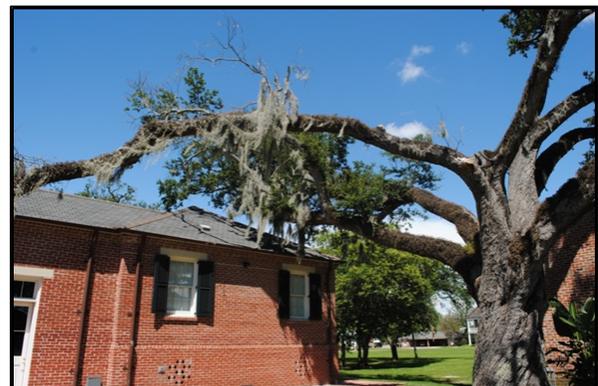
Overhanging Trees: Large branches were found hanging over several of the residential structures and one had been struck by lightning. The subject trees should be selectively trimmed to avoid damage to the building in a high-wind event.

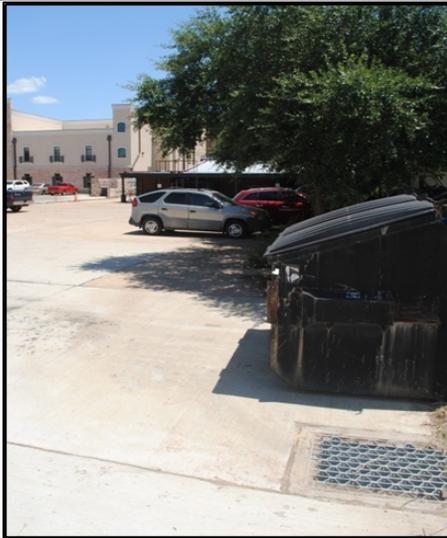
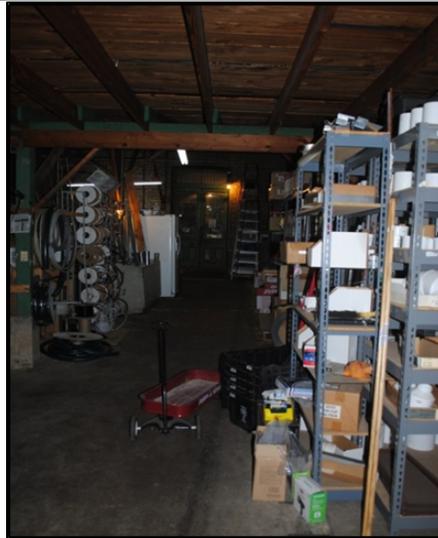
Flooding Inside Structure: The storeroom in the back of the property has previously experienced flooding caused by drainage problems. Numerous buildings along Front St. have had flooding issues from the same source, and these episodes seem to be precipitated by periods of heavy rainfall. Drainage improvement projects should be explored to prevent further flooding events.

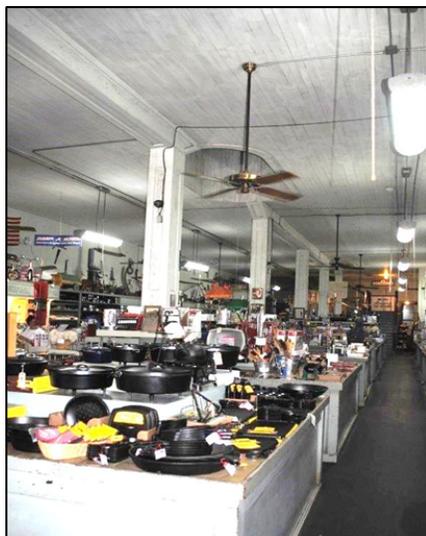
Fire Hazard: Since most of the building’s interior is primarily built of wood, the current owner is concerned with fire vulnerabilities due to lightning strikes. Consideration of a lightning protection system is recommended to prevent possible loss.

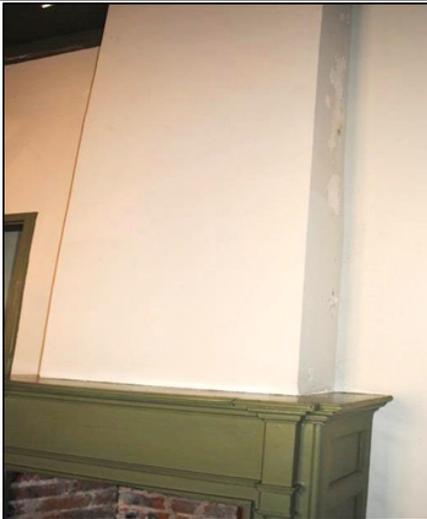
Exterior & Interior Building Envelope Damage: Plaster that was applied over the brick structural walls has caused serious and recurring moisture issues to the exterior and interior building envelope. The bricks, which naturally retain moisture, are not able to dry properly due to the plaster application.

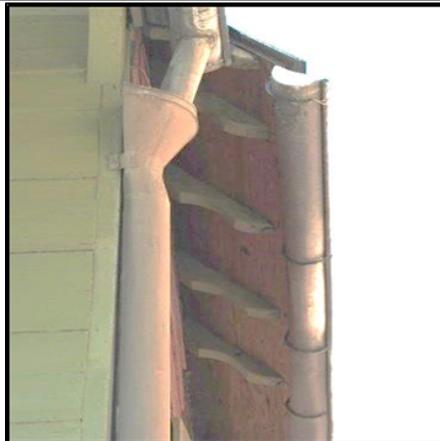
Non-Structural Component Attachment: The gutter system on the side of the building needs additional support to prevent the gutter from tilting. Non-structural components not properly attached can become wind-borne debris sources in high-wind events.

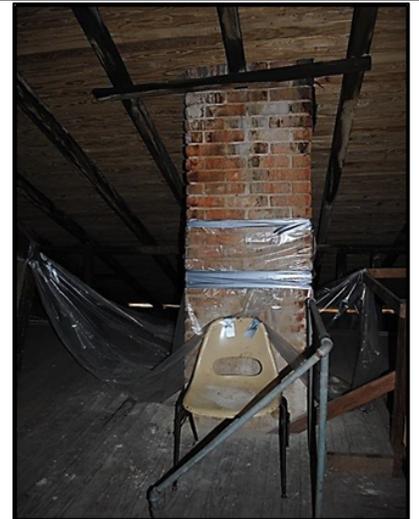
Interior Moisture Damage: Slate tiles around the central chimney are causing moisture intrusion into the interior of the structure. Plaster that was applied over the brick structural walls has caused serious and recurring moisture issues to the interior of the structure. It is recommended that an ice and water shield be installed on the roof structure to prevent further damage and that the mortar of the chimney be tuck-pointed.

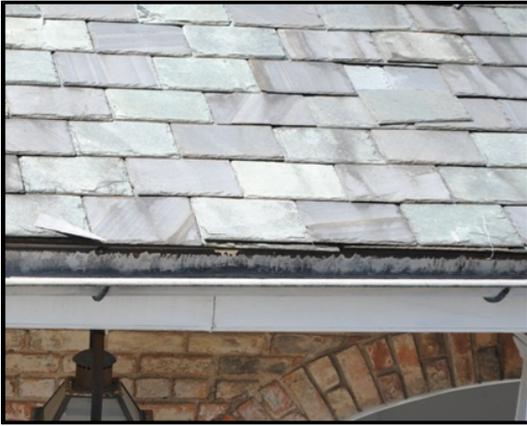
Wind-Borne Debris Source: Loose Slate tiles were detected on the roof of the neighboring building, to the rear of the property. Since loose tiles can become wind-borne debris sources in high-wind events, it is recommended that routine checks of roof tile attachment be made.

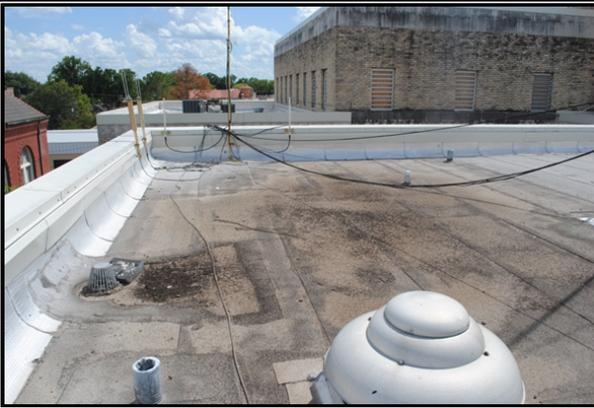
Ponding Issue: Roof membrane damage was detected on the roof of the rear building. Debris should be removed periodically from the roof drain to prevent the restriction of rain runoff, and supplemental roof drainage should be considered.

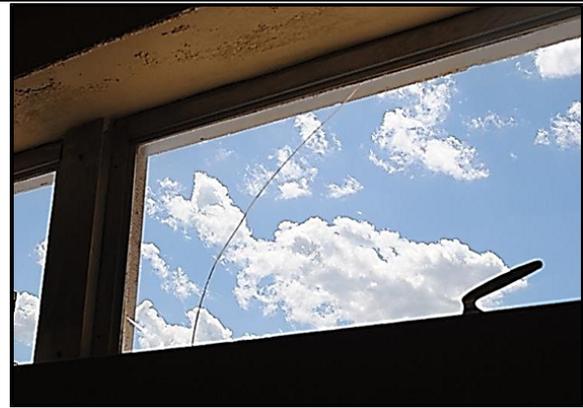
Non-Impact Resistant Windows: Broken glass panes were found on the first and fourth floor.

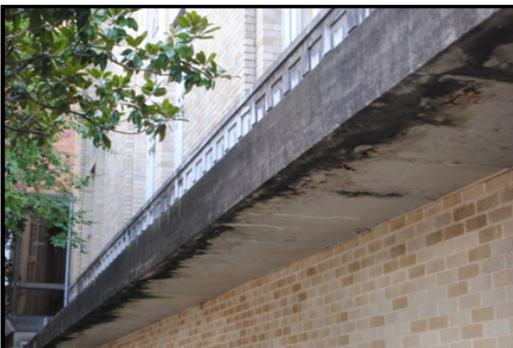
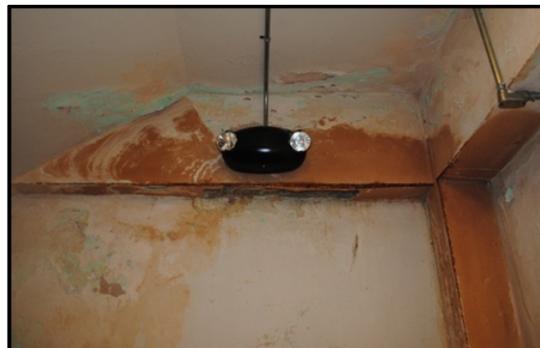
Moisture Damage to Exterior Building Envelope and Interior: The concrete overhang at the back of the rear building is causing moisture issues that are deteriorating exterior and interior building components. The tar covering of the concrete overhang is in poor condition. Other moisture problems were observed around the windows (pictured above in separate comment) of the same building.

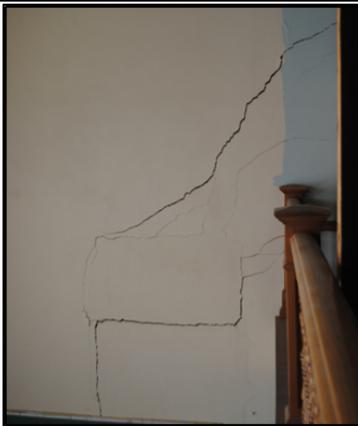
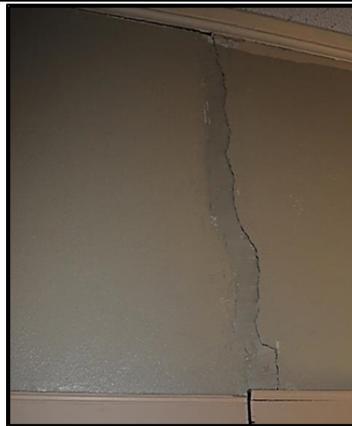
Cracks in Structural Walls: Large cracks were observed on the north-facing interior, structural wall, which supports the two story loft and large hipped roof.

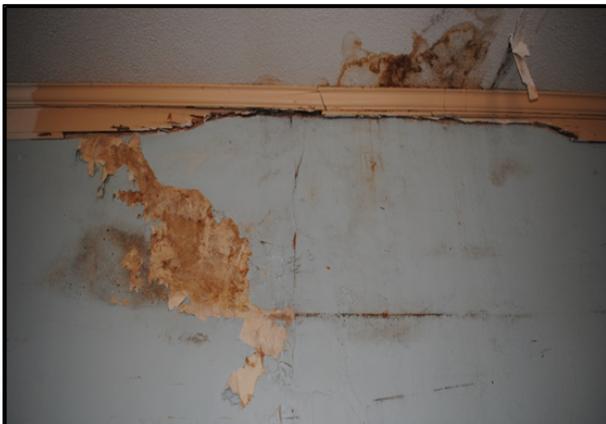
Interior Moisture Damage: Deterioration of the plaster application over the brick structural walls was detected. Mortar joints should be tuck-pointed to prevent water intrusion, causing moisture damage to the plaster, and to prevent brick failure, such as cracking.

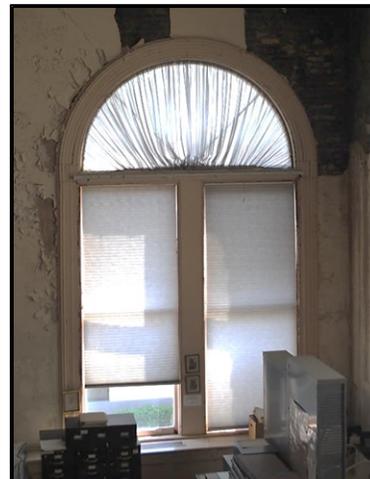
Non-Impact Resistant Windows: The building envelope is comprised of numerous non-impact resistant windows, some measuring approximately 8 feet tall, that are in fair condition.

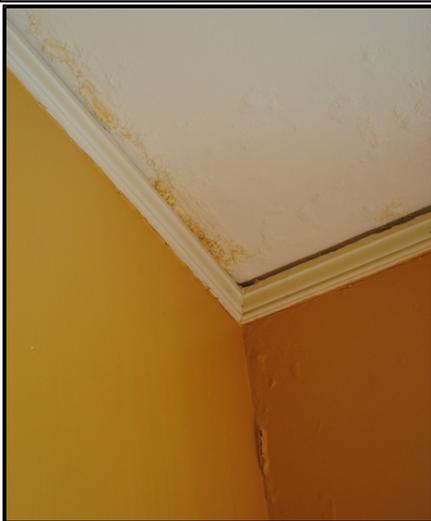
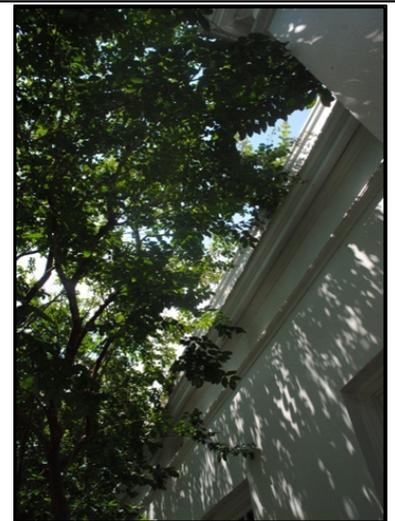
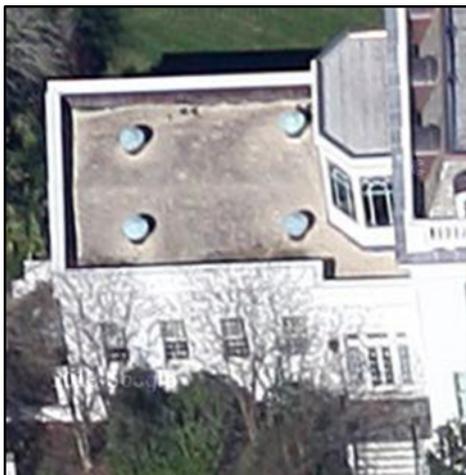
Interior Moisture Damage & Possible Roof Ponding:

Interior moisture damage was detected in the walls and ceilings of several rooms, causing serious and recurring moisture issues with the plaster.

Analysis of the roof from aerial imagery suggests that roof ponding exists over the ceiling portion that is damaged by moisture. The debris of an overhanging tree in this area may be clogging the roof drain, aggravating the moisture issue.

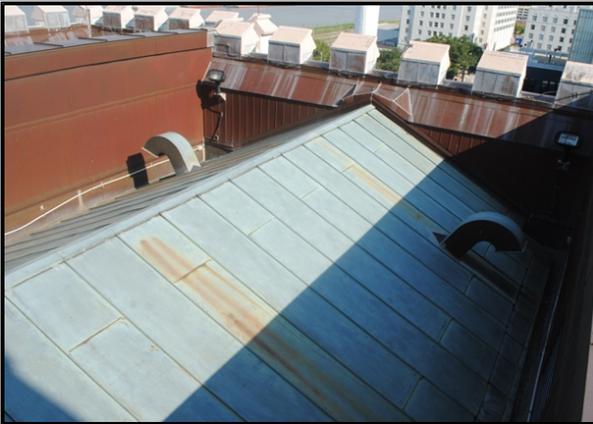
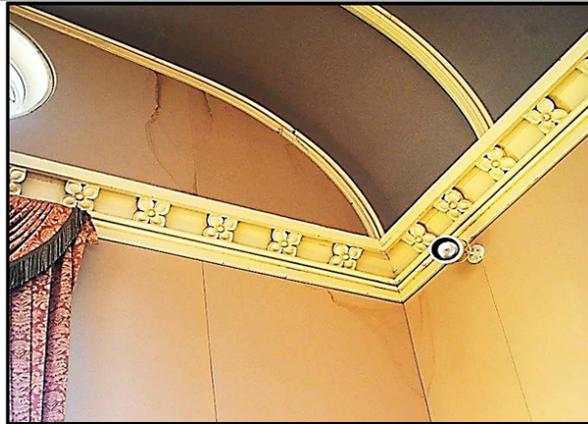
Deterioration of Exterior Building Envelope: While the roof structure and covering is very well maintained, temporary fixes are in place on several locations throughout the roof system that could become problematic in the event of a major storm. The exact locations of the problem areas exist in the valleys of the gable roof structures, which have caused leaking in the interior. Such water damage includes interior walls (pictured above) and hardwood flooring.

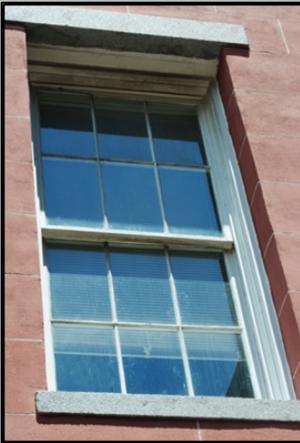
Window Protection for Non-Impact Resistant Windows: Non-impact resistant windows are susceptible to water infiltration once broken. It is recommended that window protection be used in the case of high-wind events.

Deterioration of wood trim was observed on the south end of the building.

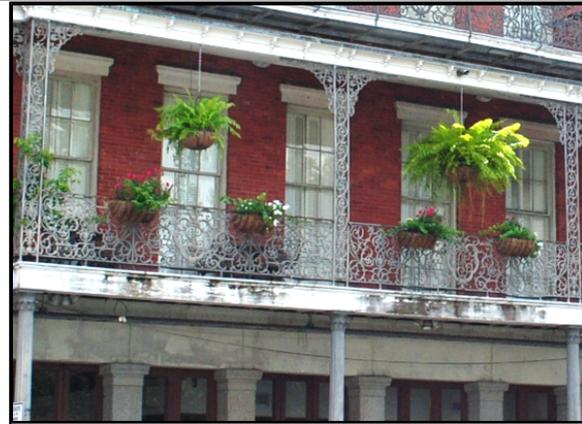
Deterioration of Exterior Building Components: Deterioration of wood trim was observed on the South Upper Pontalba building.

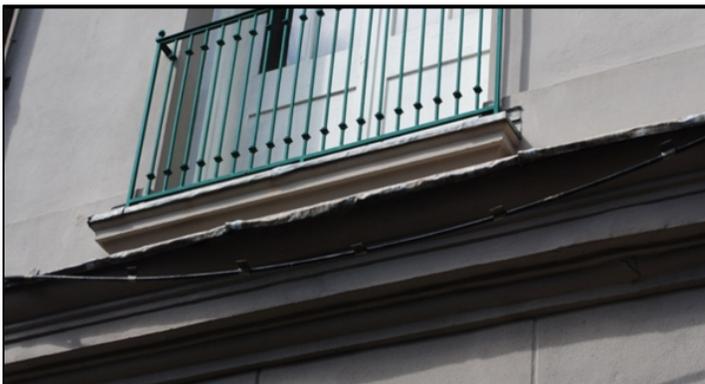
Non-Structural Component Attachment:

Unattached conduit was observed below the second-story ledge on St. Ann St. Non-structural components not properly attached can become wind-borne debris sources in high-wind events.

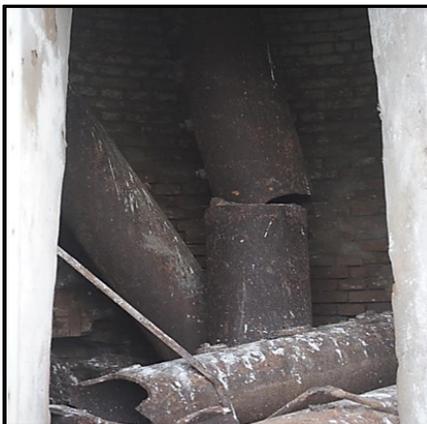
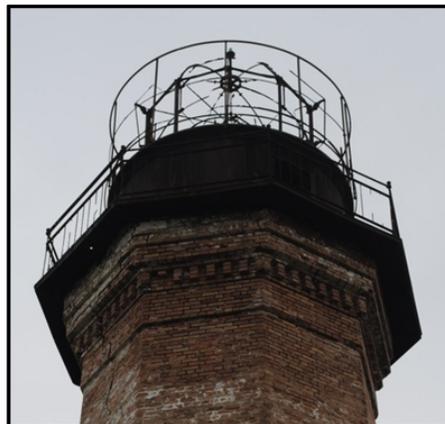
Missing Roof Covering: The copper roof covering was stolen in the 1970s, leaving the interior portion of the structure exposed to the elements.

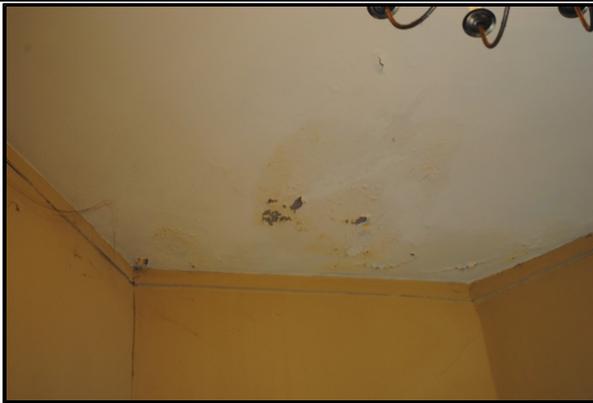
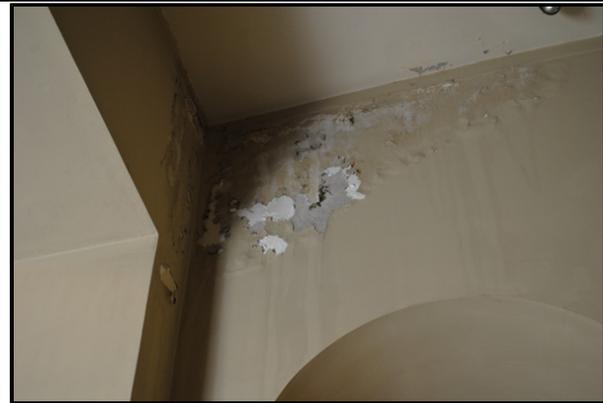
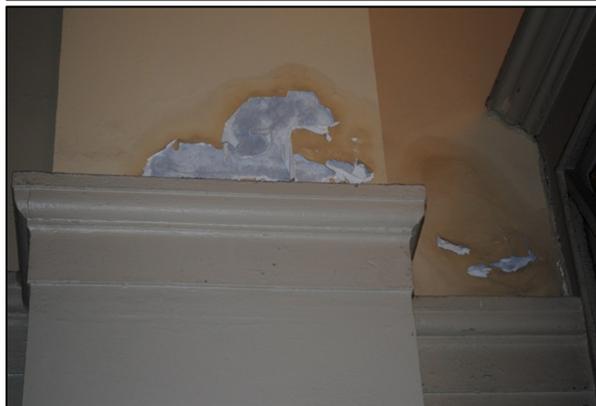
Interior Moisture Damage: Deterioration of the plaster application over the brick structural walls was detected. Mortar joints should be tuck-pointed to prevent water intrusion (which causes moisture damage to the plaster) and to prevent brick failure (such as cracking).

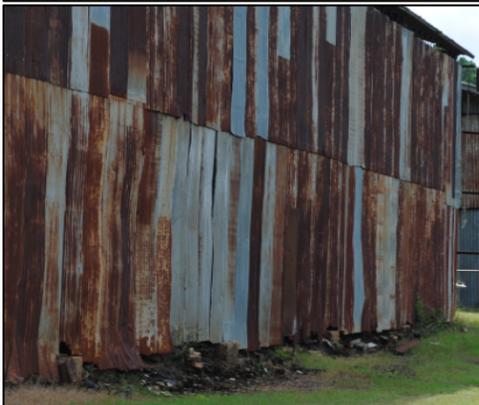
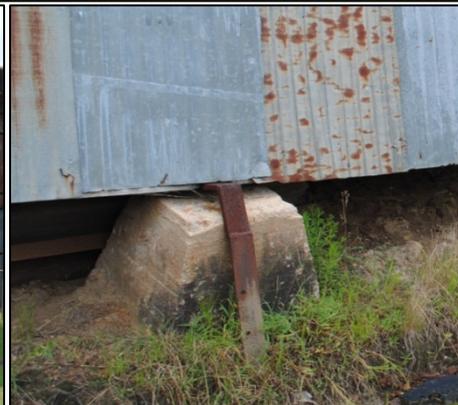
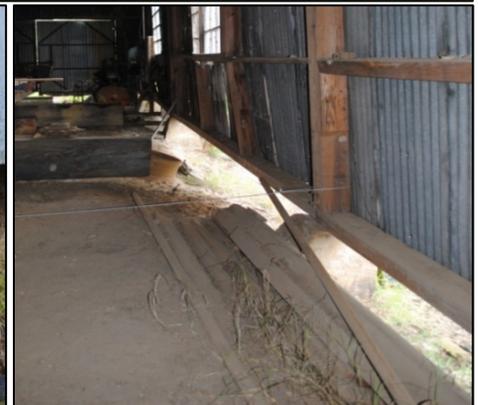
Erosion of Foundation: Storm water runoff from an uphill area is eroding and destabilizing the soil at the base of the machine shop, round house, and car knocker shed. As a result, the foundations are being undermined, threatening the stability of the structures.

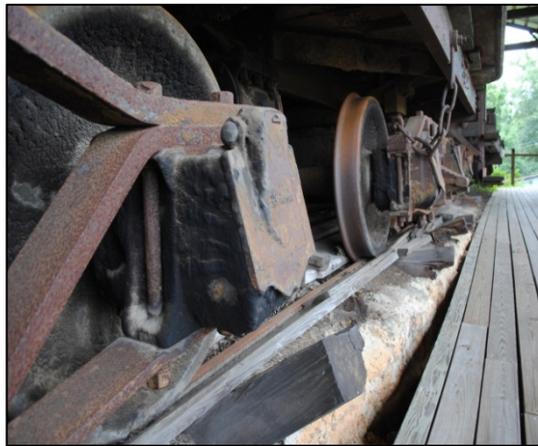
Foundation Issue: The foundation the antique steam engine sits on appears to be sinking. The train car is situated atop a hill that may be sloughing off due to runoff.

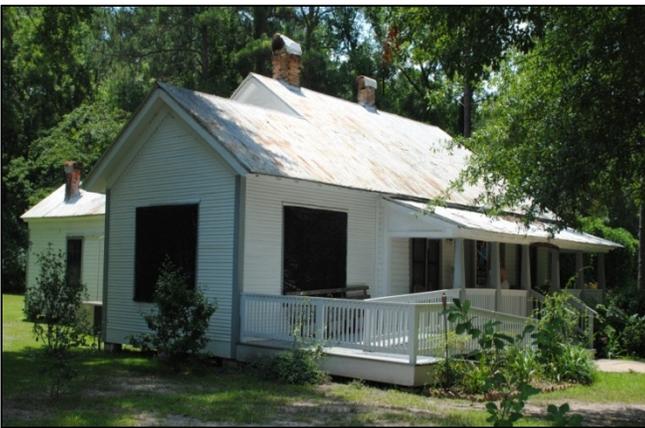
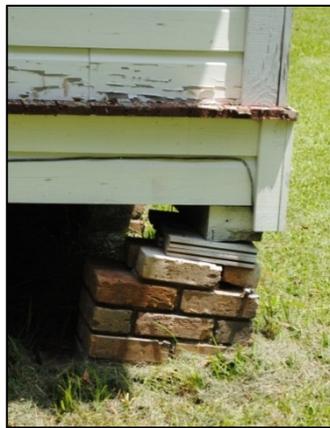
Foundation Issue: The pier foundation of the museum must be leveled and is in need of permanent repair.

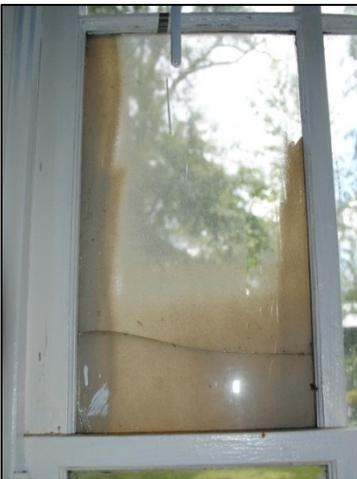
can cause water infiltration into the interior of the building.

Non-Impact Resistant Windows: Several non-impact resistant windows were observed during the inspection. Non-impact resistant windows are susceptible to water infiltration once broken and

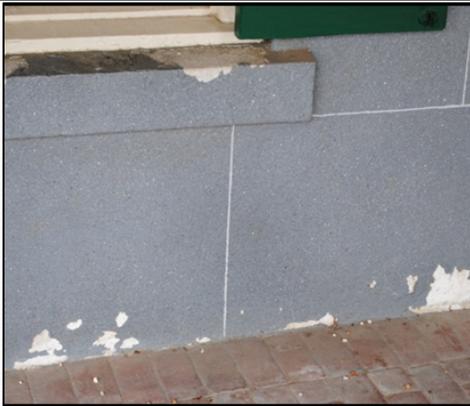
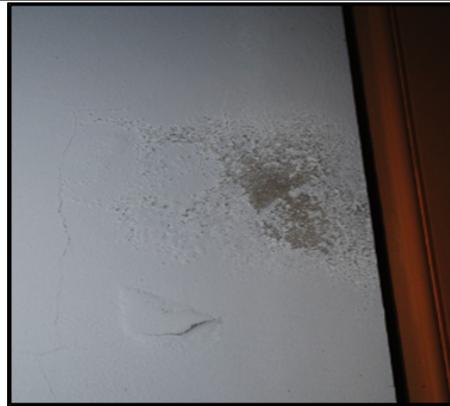
Moisture Damage: Moisture damage was detected on the exterior and interior walls, as well as the ceilings.

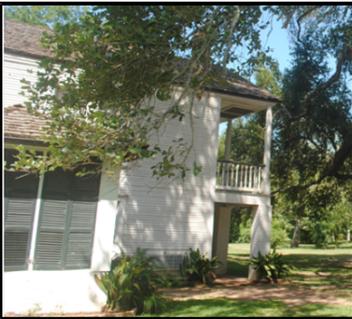
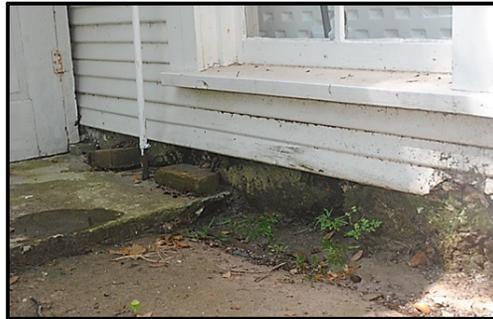
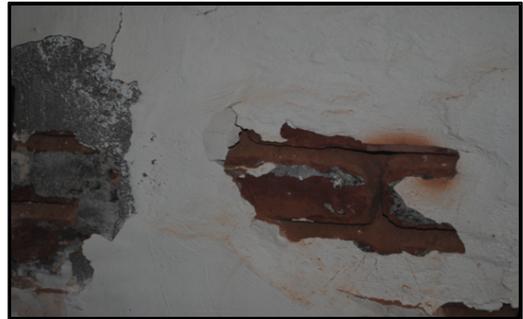
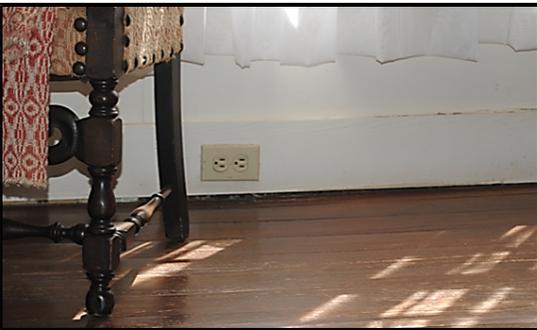
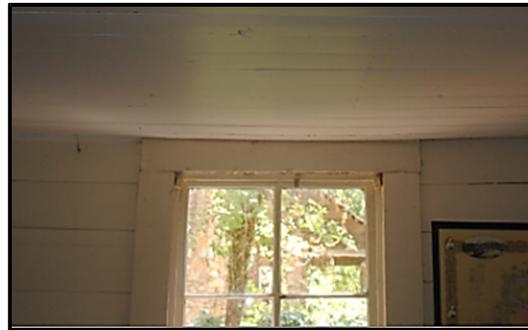
Structural Stability Concern: A two-story portion of the main house, located in the rear of the structure, shakes when persons walk in the upstairs portion. Upon inspection of the upstairs room (Candy Henry bedroom), a gap under the baseboard was observed and the floor drooped in that same area. Inspection of the ground floor room reflected the findings above, revealing a drooped ceiling above a window. Further inspection of the ground floor revealed that the interior masonry wall has suffered mortar deterioration. Exterior inspection of the wing showed deterioration of the foundation, directly under the window with the drooped ceiling above.

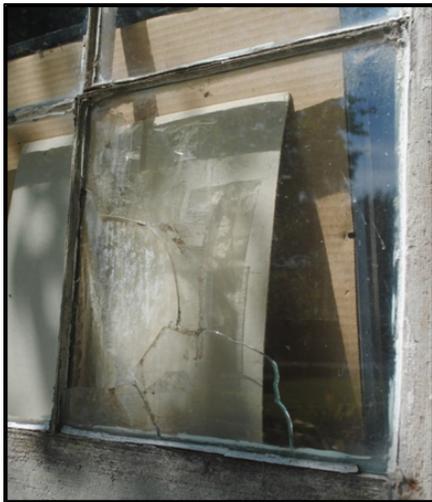
Window Protection for Non-Impact Resistant Windows: Broken windows were detected in the rear room of the Main House and in the Admissions building. Non-Impact resistant windows are susceptible to water infiltration once broken and could cause moisture issues in the interior of the building.

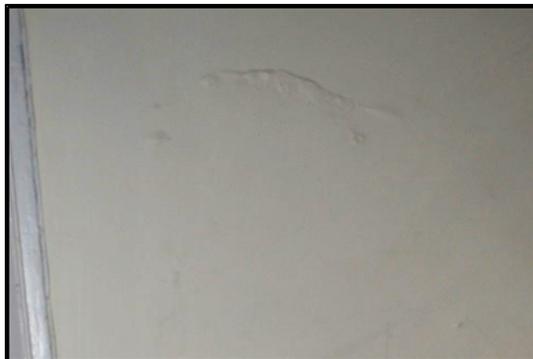
Interior Moisture Damage: Deterioration of the plaster application over the brick structural walls was detected. Mortar joints should be tuck-pointed to prevent water intrusion, causing moisture damage to the plaster, and to prevent brick failure, such as cracking.

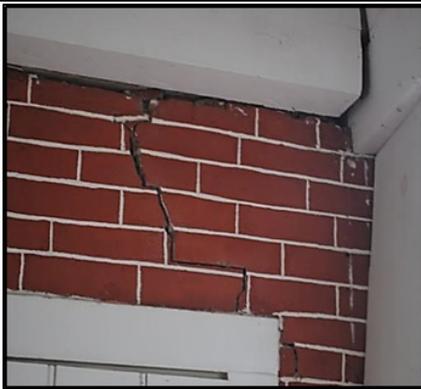
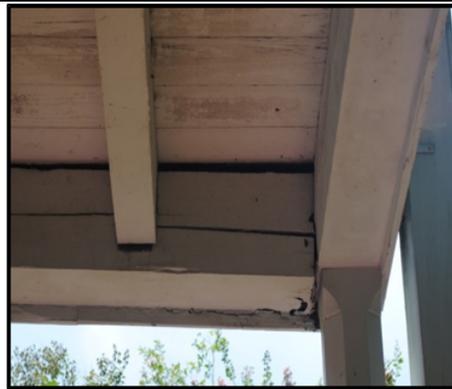
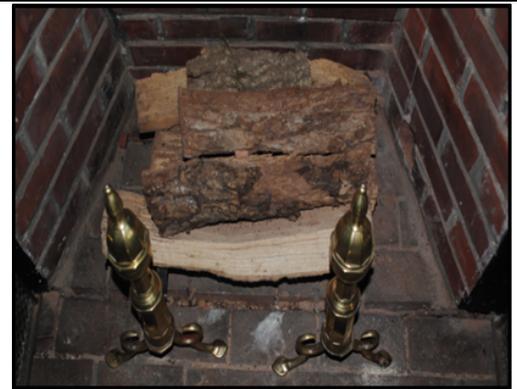
Cracks and Movement in Structure: Large shear cracks and gaps were found on the rear facing exterior masonry wall and rear porch structure. Gaps between the main structure and each fireplace show that the chimney is separating from the house. Each of these issues is likely attributed to foundation issues.

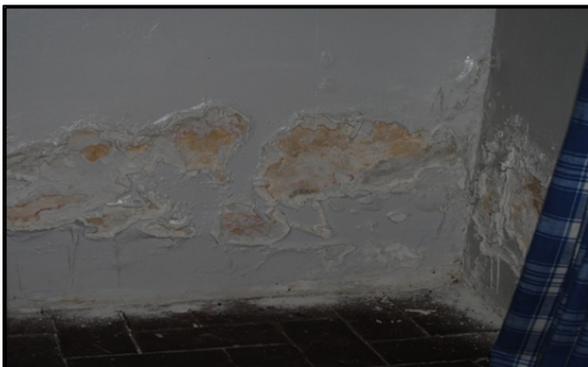
Interior Moisture Damage: Deterioration of the plaster application over the brick structural walls was detected. Mortar joints should be tuck-pointed to prevent water intrusion (which causes moisture damage to the plaster), and to prevent brick failure (such as cracking).

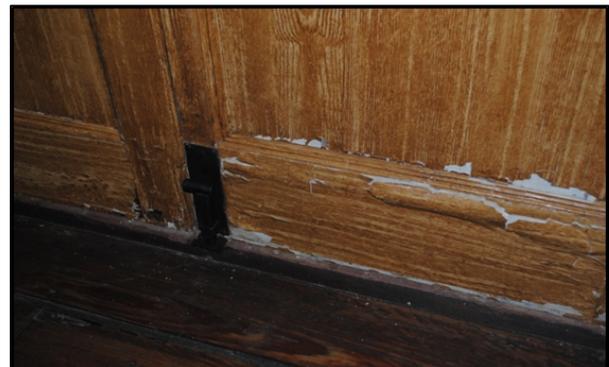
Deterioration of Exterior Door: Exterior doors were found to be in fair-poor condition due to gaps in the wood joints, which make the interior prone to wind-driven rain intrusion.

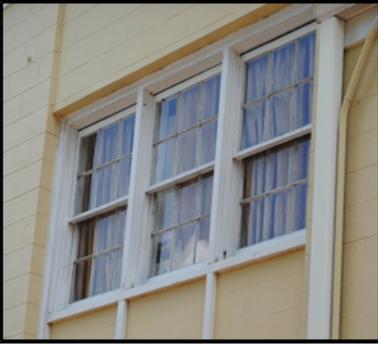
Window Protection for Non-Impact Resistant Windows: Window protection should be used during high-wind events, since non-Impact resistant windows are susceptible to water infiltration once broken. Locking mechanisms of shutters should be inspected regularly.

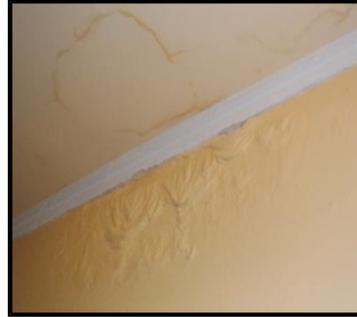
Moisture Damage: Moisture damage was detected on the interior wall.

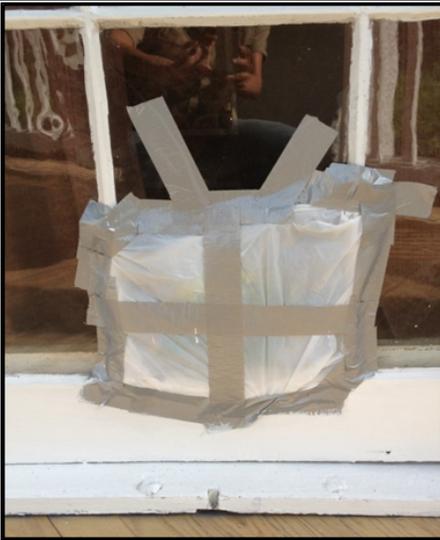
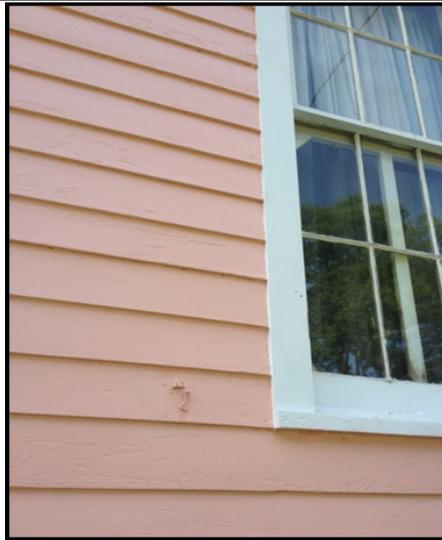
Window Protection for Non-Impact Resistant Windows: Several broken window panes were found throughout the first floor and storm shutters have been removed from the structure. Window protection should be used during high-wind events, since non-impact resistant windows are susceptible to water infiltration once broken.

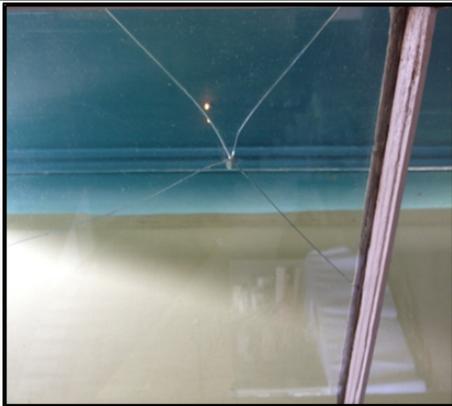
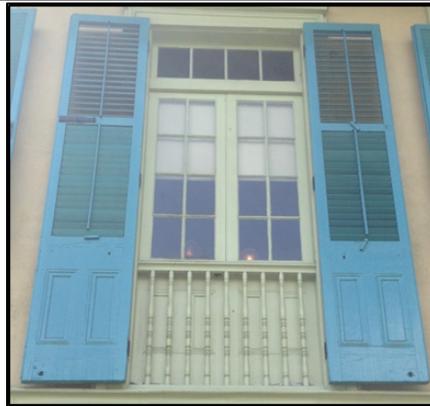
Shutter Protection of Non-Impact Resistant Windows: Window protection should be used in the case of high-wind events because non-impact resistant windows are susceptible to water infiltration once broken. Locking mechanisms of shutters should be inspected regularly, and large plantation shutters should have multiple locks. Interior of structure sustained water damage during Hurricane Katrina, due to shutter failure.

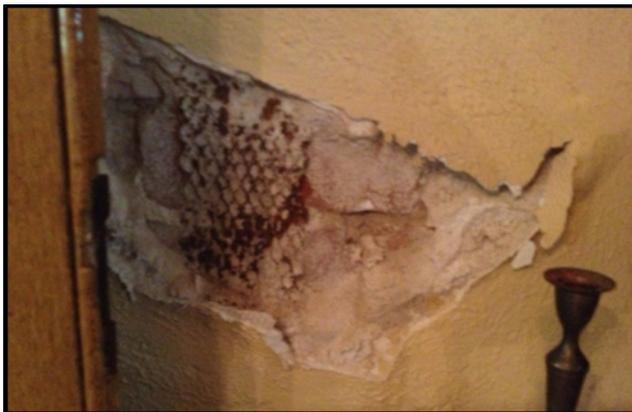
Interior Moisture Damage: Deterioration of the plaster application over the brick structural walls was detected. Mortar joints should be tuck-pointed to prevent water intrusion, causing moisture damage to the plaster, and to prevent brick failure, such as cracking.

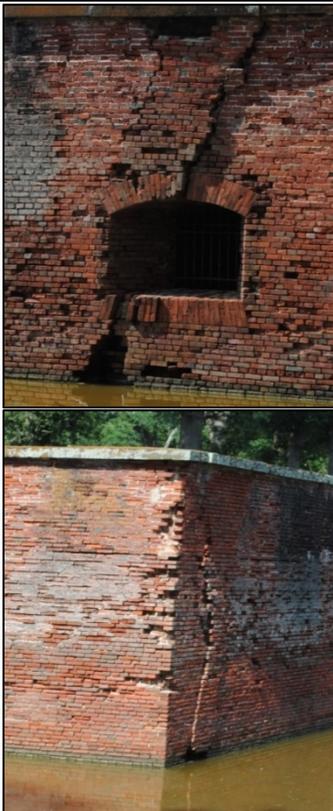
Cracks and Movement in Structural Walls: Severe cracks of the outer, masonry structural walls were observed throughout the perimeter of the structure. Stepped shear cracks, specifically ones involving the widow openings, have resulted in the loss of masonry units.

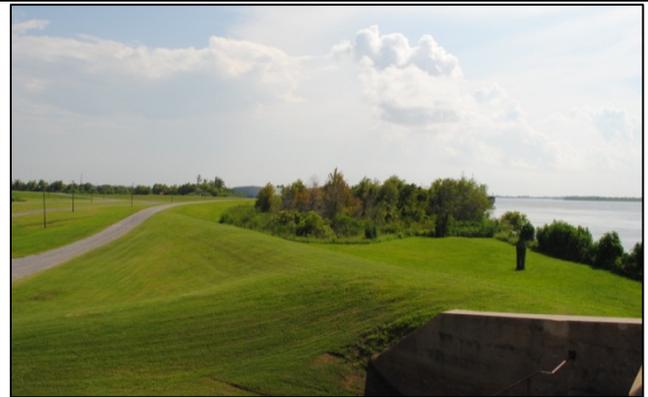
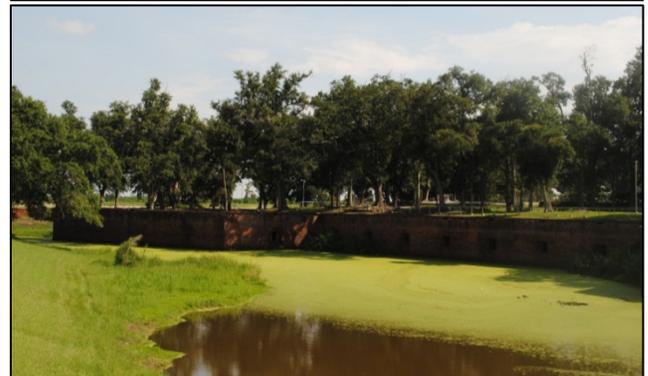
Storm Surge/Flooding: Persons involved with the property have voiced concern about flood inundation in the event of future natural hazard events. The fort was damaged in Hurricanes Katrina and Isaac by storm surge and extended periods of flood inundation.

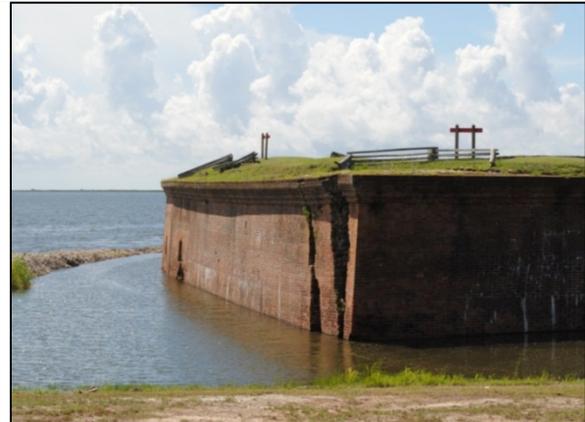
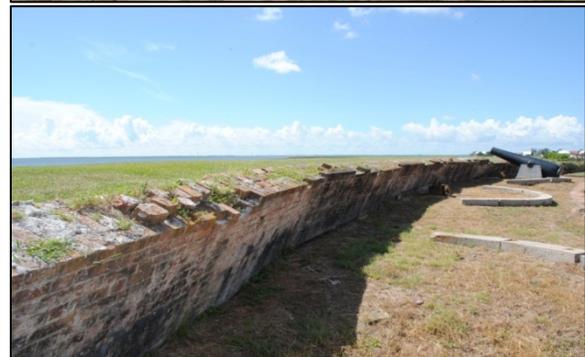
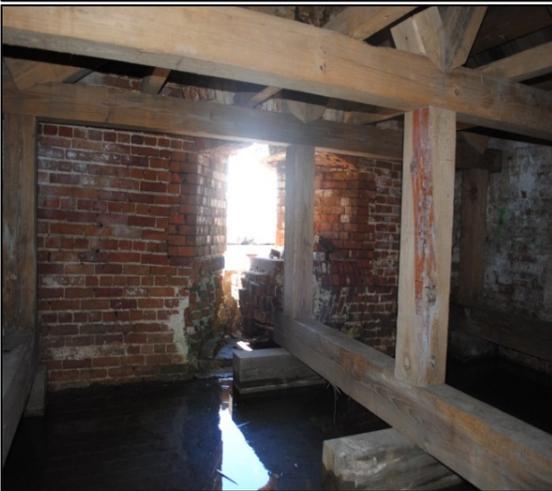
Cracking and Movement of Structural Walls and Water Intrusion: Severe cracking of masonry walls was observed on the corners of the structure and at window openings. Standing water was present in the rooms facing the open waterway. Deterioration of the brick and mortar was severe in numerous areas. This structure sustained substantial damage from storm surge during Hurricanes Katrina and Isaac.
