3. STATE HISTORICAL PROPERTIES RISK ASSESSMENT

INTRODUCTION

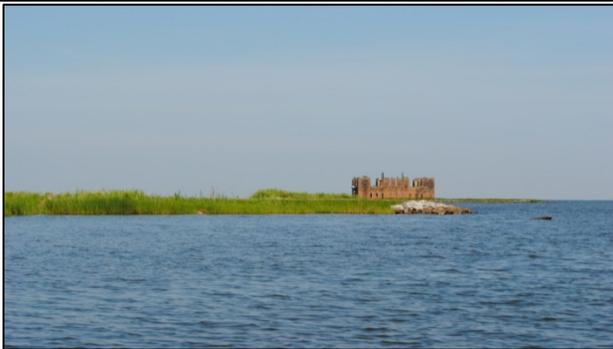
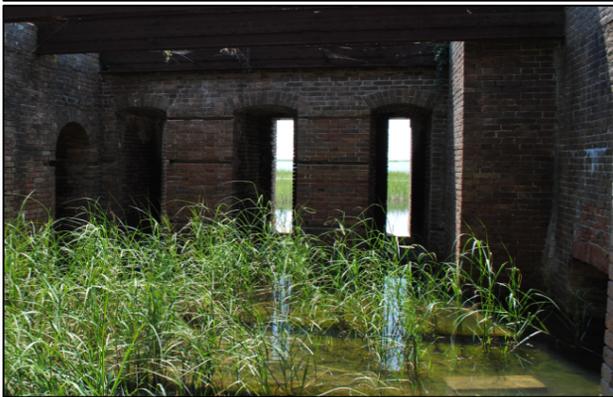
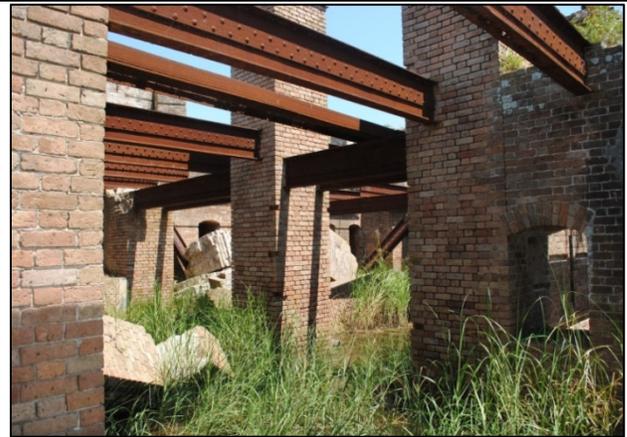
Coastal Erosion, Subsidence, Wind, and Storm Surge Damage: Fort Proctor is in serious disrepair and is currently inundated by 1.5 feet of water. Many of the second story masonry walls have collapsed and have fallen to the ground floor, presumably from hurricane wind and storm surge damage. With increased sea level rise, active coastal erosion, and subsidence issues, increased inundation of the ground floor is expected.

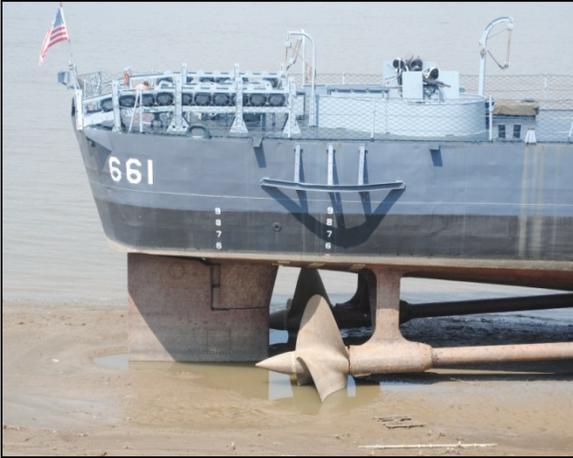
Flood By-Product: Riverine silt has buried the bottom portion of the propeller of the *USS Kidd*. While silt deposits are naturally occurring, the May 2011 flood event amplified the amount that currently exists over the propeller. Excavation of at least 3–4 feet of silt is needed to uncover the propeller and rear portion of the ship.

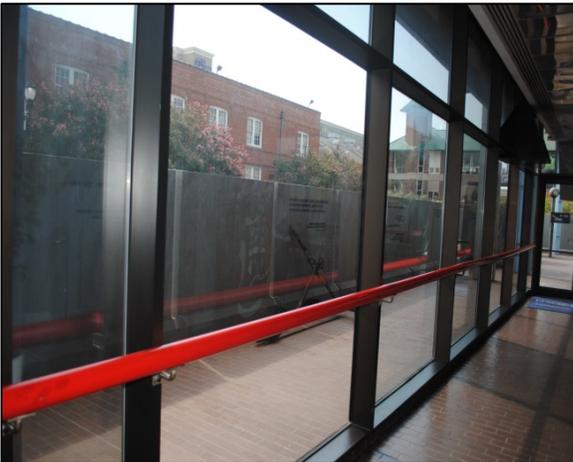
Window Protection for Non-Impact Resistant Windows: The exterior building envelope of the first and second floor is composed of floor to ceiling windows that are not impact resistant. Breakage of the subject windows has occurred within the last 5 years. It is recommended that window protection be used in the case of high-wind events.
